Access Compliance Report

Public Rights-of-Way

(Curb Ramps)

Intersection ID: 20532	Main Street: FAIRVIEW_RD	Cross Street: SIMSBURY RD	Location: SE
ADA ID: B227BDA87501	Ramp Type: PerpDiag	Initial Pass/Fail: Fail	Overall Compliance: No
		Severity Score: 25

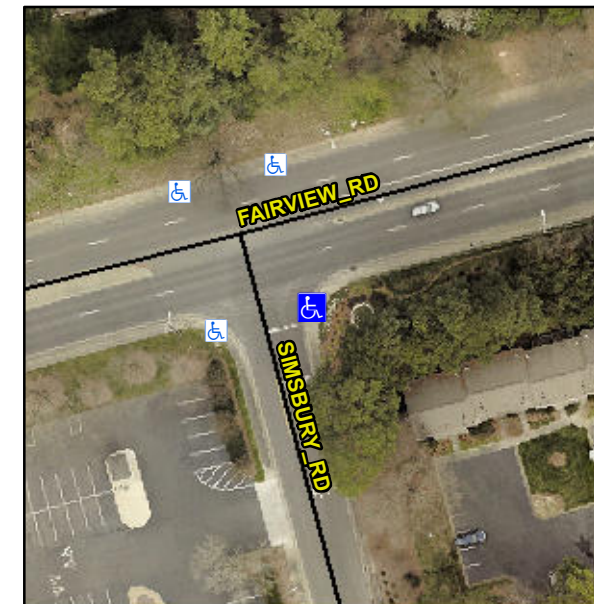
Not Found, R304.2.2, R304.5.3

Compliance	Description	Data	Compliance	Description	Data
N/A	Ramp Length (in)	70.0	No	Ramp Slope (%)	8.9
Yes	Ramp Width (in)	48.0	No	Ramp XSlope (%)	6.2
N/A	Flare Type LT	N/A	N/A	Flare Type RT	N/A
N/A	Flare Slope LT (%)	N/A	N/A	Flare Slope RT (%)	N/A
N/A	Flare Traversable LT?	N/A	N/A	Flare Traversable RT?	N/A
N/A	Landing Length (in)	N/A	N/A	DWS Provided?	N/A
N/A	Landing Width (in)	N/A	N/A	DWS Contrast?	N/A
N/A	Landing Slope (%)	N/A	N/A	DWS Length (in)	N/A
N/A	Landing X Slope (%)	N/A	N/A	DWS Full Width?	N/A
N/A	Landing Curb? (Y/N)	N/A	N/A	DWS Offset (in)	N/A
N/A	Shared Landing?	N/A			
N/A	Gutter Ponding?	N/A	N/A	Gutter Slope (%)	N/A
N/A	Gutter Lip Ht (in)	N/A	N/A	Gutter X Slope (%)	N/A
N/A	Painted X Walk1?	No	N/A	Painted X Walk2?	No
	X Walk 1 Direction	To N		X Walk 2 Direction	To W
N/A	X Walk 1 Width (in)	N/A	N/A	X Walk 2 Width (in)	N/A
	X Walk 1 Slope (%)	3.3		X Walk 2 Slope (%)	5.6
	X Walk 1 X Slope (%)	2.3		X Walk 2 X Slope (%)	5.1

N/A	Ramp inside XWalk1?	N/A	N/A	Ramp inside XWalk2?	N/A
	Road Slope (%)	3.8	N/A	Clear Space?	N/A
	Road X Slope (%)	0.3	N/A	Clear Space to XWalk (in)	N/A
N/A	Any Obstructions?	N/A	N/A	Storm Grate/Utility Hazard?	N/A
	Obstruction Type			Storm Grate/Utility Type	
		N/A			N/A
			Yes	Surface Condition? (G/P)	Good

Remove & Replace Curb Ramp With Two New Directional Ramps or Equivalent.

Total Cost: \$ 3200.00
