# Access Compliance Report

## Public Rights-of-Way

### (Curb Ramps)

Intersection ID: 22868	Main Street: KALANCHOE_DR	Cross Street: SARDIS_POINTE_RD	Location: E
ADA ID: B22E28C267F1	Ramp Type: PerpDiag	Initial Pass/Fail: Fail	Overall Compliance: No
Severity Score: 12.5			
Codes/Mitigation Info/Possible Solution		Field Measurements/Component Compliance

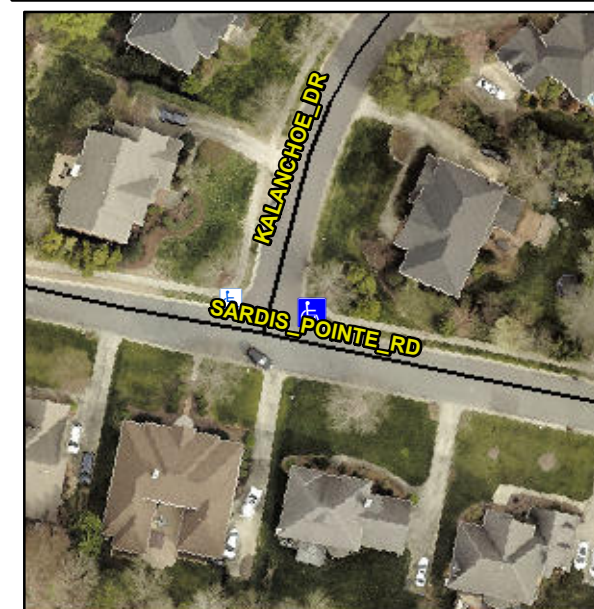
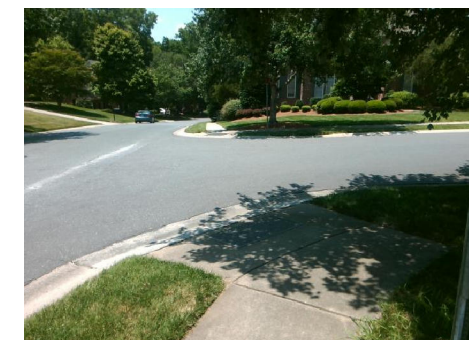
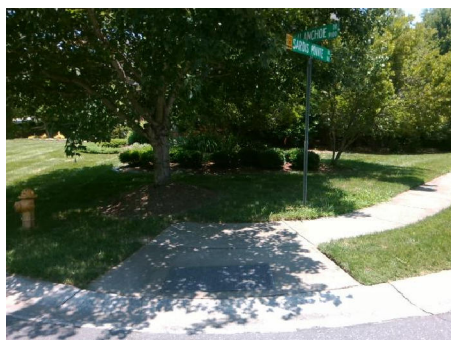
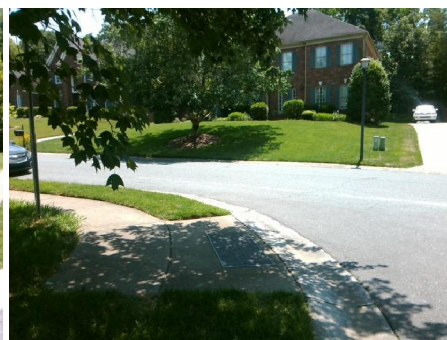
Compliance	Description	Data	Compliance	Description	Data
N/A	Ramp Length (in)	51.0	Yes	Ramp Slope (%)	6.6
Yes	Ramp Width (in)	48.0	No	Ramp XSlope (%)	5.7
N/A	Flare Type LT	N/A	N/A	Flare Type RT	N/A
N/A	Flare Slope LT (%)	N/A	N/A	Flare Slope RT (%)	N/A
N/A	Flare Traversable LT?	N/A	N/A	Flare Traversable RT?	N/A
N/A	Landing Length (in)	N/A	N/A	DWS Provided?	N/A
N/A	Landing Width (in)	N/A	N/A	DWS Contrast?	N/A
N/A	Landing Slope (%)	N/A	N/A	DWS Length (in)	N/A
N/A	Landing X Slope (%)	N/A	N/A	DWS Full Width?	N/A
N/A	Landing Curb? (Y/N)	N/A	N/A	DWS Offset (in)	N/A
N/A	Shared Landing?	N/A			
N/A	Gutter Ponding?	N/A	N/A	Gutter Slope (%)	N/A
N/A	Gutter Lip Ht (in)	N/A	N/A	Gutter X Slope (%)	N/A
N/A	Painted X Walk1?	No	N/A	Painted X Walk2?	No
	X Walk 1 Direction	To NW		X Walk 2 Direction	To SW
N/A	X Walk 1 Width (in)	N/A	N/A	X Walk 2 Width (in)	N/A
	X Walk 1 Slope (%)	1.3		X Walk 2 Slope (%)	2.3
	X Walk 1 X Slope (%)	2.2		X Walk 2 X Slope (%)	2.0

N/A	Ramp inside XWalk1?	N/A	N/A	Ramp inside XWalk2?	N/A
	Road Slope (%)	0.3	N/A	Clear Space?	N/A
	Road X Slope (%)	2.2	N/A	Clear Space to XWalk (in)	N/A
N/A	Any Obstructions?	N/A	N/A	Storm Grate/Utility Hazard?	N/A
	Obstruction Type			Storm Grate/Utility Type	
		N/A			N/A
		Yes		Surface Condition? (G/P)	Good

Possible Solutions:

**Remove & Replace Curb Ramp With Two New Directional Ramps or Equivalent.**

**Not Found, R304.5.3**

Total Cost: \$ 3200.00
