Access Compliance Report

Public Rights-of-Way

(Curb Ramps)

Intersection ID: 13701	Main Street: SPRUCE_ST	Cross Street: WILMORE_DR	Location: NW
ADA ID: B235C156200A	Ramp Type: ParaDiag	Initial Pass/Fail: Fail	Overall Compliance: No
		Severity Score: 25

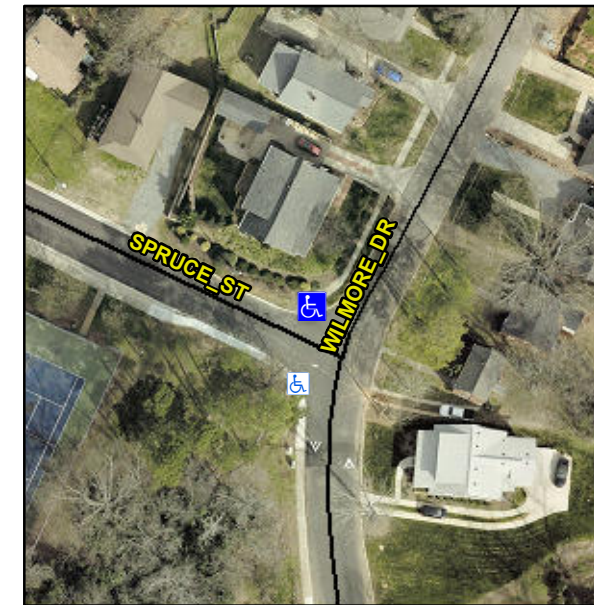
Compliance	Description	Data	Compliance	Description	Data
N/A	Ramp Length LT (in)	N/A	N/A	Ramp Length RT (in)	49.0
N/A	Ramp Width LT (in)	N/A	Yes	Ramp Width RT (in)	118.0
N/A	Ramp Slope LT (%)	N/A	No	Ramp Slope RT (%)	12.1
N/A	Ramp XSlope LT (%)	N/A	Yes	Ramp XSlope RT (%)	1.3
N/A	Landing Length (in)	N/A	N/A	DWS Provided?	N/A
N/A	Landing Width (in)	N/A	N/A	DWS Contrast?	N/A
N/A	Landing Slope (%)	N/A	N/A	DWS Length (in)	N/A
N/A	Landing X Slope (%)	N/A	N/A	DWS Full Width?	N/A
N/A	Landing Curb? (Y/N)	N/A	N/A	DWS Offset (in)	N/A
N/A	Shared Landing?	N/A			
N/A	Gutter Ponding?	N/A	N/A	Gutter Slope (%)	N/A
N/A	Gutter Lip Ht (in)	N/A	N/A	Gutter X Slope (%)	N/A
N/A	Painted X Walk1?	No	N/A	Painted X Walk2?	No
	X Walk 1 Direction	To SW		X Walk 2 Direction	To SE
N/A	X Walk 1 Width (in)	N/A	N/A	X Walk 2 Width (in)	N/A
	X Walk 1 Slope (%)	0.2		X Walk 2 Slope (%)	2.4
	X Walk 1 X Slope (%)	4.4		X Walk 2 X Slope (%)	1.4
N/A	Ramp inside XWalk1?	N/A	N/A	Ramp inside XWalk2?	N/A

Road Slope (%)	4.8	N/A	Clear Space?	N/A
	Road X Slope (%)	2.7	N/A	Clear Space to XWalk (in)	N/A
N/A	Any Obstructions?	N/A	N/A	Storm Grate/Utility Hazard?	N/A
	Obstruction Type			Storm Grate/Utility Type	
		N/A			N/A
			Yes	Surface Condition? (G/P)	Good
			N/A	Curb Slope (%)	12.0

Possible Solutions:

Remove & Replace Curb Ramp With Two New Directional Ramps or Equivalent.

R304.3.2

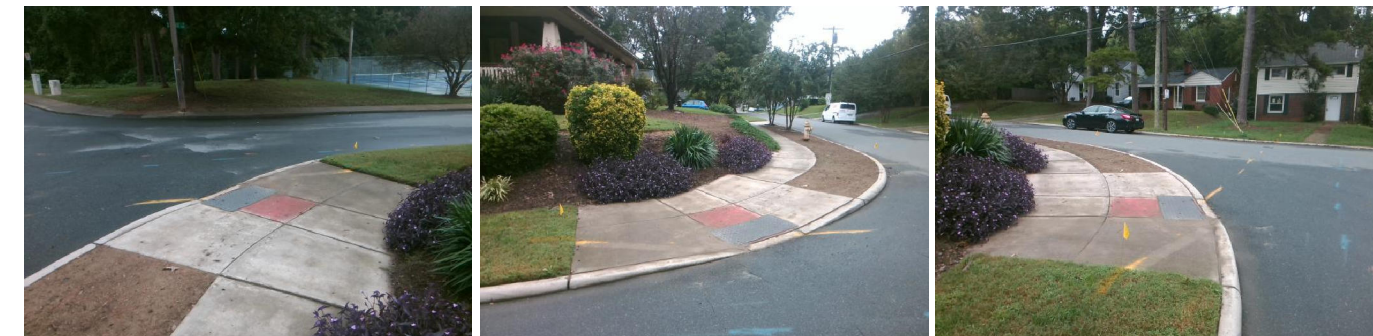
Street 1 Name **SPRUCE ST**
 Stop Condition-Street 1 **StopSign**
 Street 2 Name **WILMORE DR**
 Stop Condition-Street 2 **None**
