# Access Compliance Report

## Public Rights-of-Way

### (Curb Ramps)

| Intersection ID: 7014 | Main Street: BROOKWOOD_RD | Cross Street: BLAZE_MANOR_LN | Location: SW |

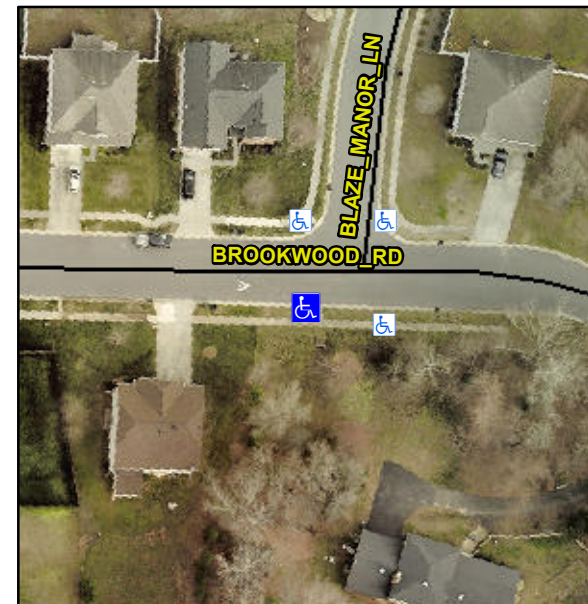
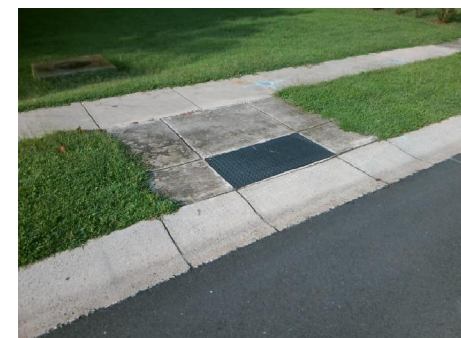
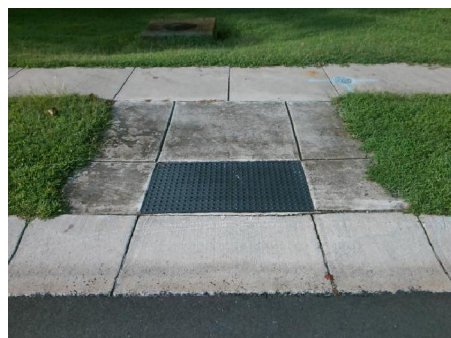
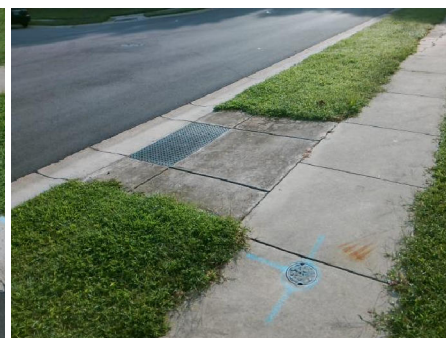
**Not Found, R304.5.3, R304.5.4**

| Compliance | Description | Data | Compliance | Description | Data |
|---|---|---|---|---|---|
| No | Landing X Slope (%) | 3.3 | Yes | DWS Full Width? | Yes |
| Yes | Gutter Ponding? | No | No | Gutter Slope (%) | 9.5 |
| Yes | Gutter Lip Ht (in) | 0.0 | No | Gutter X Slope (%) | 2.4 |

**Remove & Replace Entire Ramp.  
Remove & Replace Gutter.**

Total Cost: \$ 2600.00
