# Access Compliance Report

## Public Rights-of-Way

### (Curb Ramps)

Intersection ID: 43522	Main Street: MISTRAL_WY	Cross Street: PALM_BREEZE_LN	Location: W
ADA ID: B23EC731B47B	Ramp Type: PerpDiag	Initial Pass/Fail: Fail	Overall Compliance: No
Severity Score: 10			
Codes/Mitigation Info/Possible Solution		Field Measurements/Component Compliance

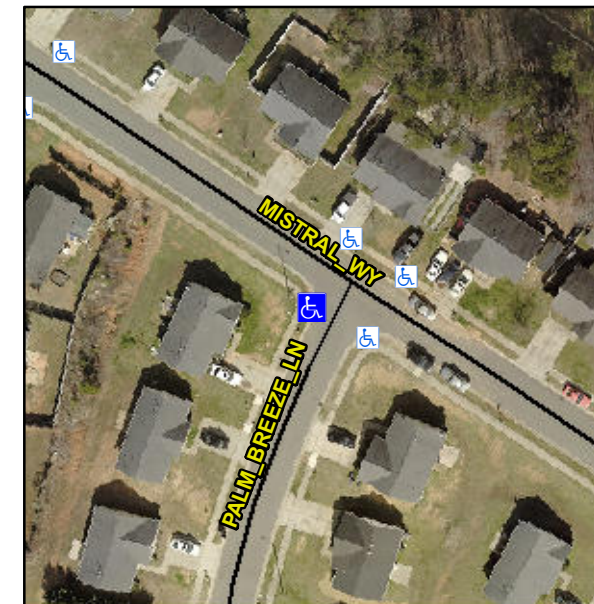
**Not Found, R304.5.1, R304.5.3**

Compliance	Description	Data	Compliance	Description	Data
N/A	Ramp Length (in)	48.0	Yes	Ramp Slope (%)	6.7
No	Ramp Width (in)	42.0	No	Ramp XSlope (%)	2.7
N/A	Flare Type LT	N/A	N/A	Flare Type RT	N/A
N/A	Flare Slope LT (%)	N/A	N/A	Flare Slope RT (%)	N/A
N/A	Flare Traversable LT?	N/A	N/A	Flare Traversable RT?	N/A
N/A	Landing Length (in)	N/A	N/A	DWS Provided?	N/A
N/A	Landing Width (in)	N/A	N/A	DWS Contrast?	N/A
N/A	Landing Slope (%)	N/A	N/A	DWS Length (in)	N/A
N/A	Landing X Slope (%)	N/A	N/A	DWS Full Width?	N/A
N/A	Landing Curb? (Y/N)	N/A	N/A	DWS Offset (in)	N/A
N/A	Shared Landing?	N/A			
N/A	Gutter Ponding?	N/A	N/A	Gutter Slope (%)	N/A
N/A	Gutter Lip Ht (in)	N/A	N/A	Gutter X Slope (%)	N/A
N/A	Painted X Walk1?	No	N/A	Painted X Walk2?	No
	X Walk 1 Direction	To SE		X Walk 2 Direction	To NE
N/A	X Walk 1 Width (in)	N/A	N/A	X Walk 2 Width (in)	N/A
	X Walk 1 Slope (%)	2.6		X Walk 2 Slope (%)	8.9
	X Walk 1 X Slope (%)	3.4		X Walk 2 X Slope (%)	2.0

N/A	Ramp inside XWalk1?	N/A	N/A	Ramp inside XWalk2?	N/A
	Road Slope (%)	2.1	N/A	Clear Space?	N/A
	Road X Slope (%)	5.6	N/A	Clear Space to XWalk (in)	N/A
N/A	Any Obstructions?	N/A	N/A	Storm Grate/Utility Hazard?	N/A
	Obstruction Type			Storm Grate/Utility Type	
		N/A			N/A
			Yes	Surface Condition? (G/P)	Good

**Remove & Replace Curb Ramp With Two New Directional Ramps or Equivalent.**

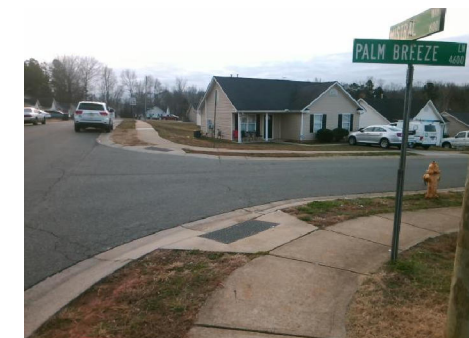
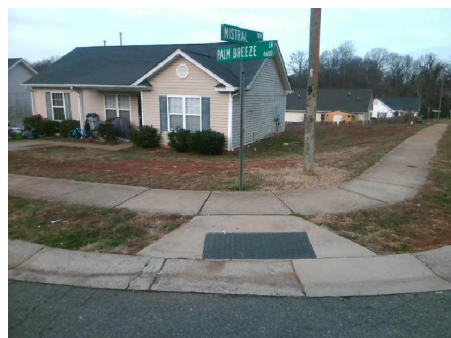
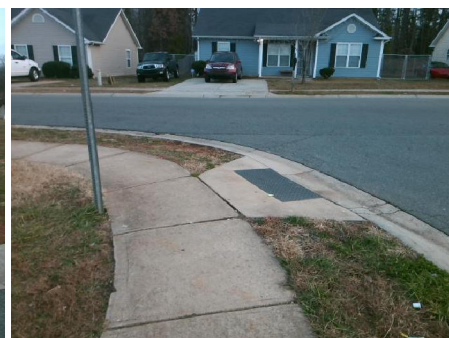
Street 1 Name **PALM BREEZE LN**  
 Stop Condition-Street 2 **StopSign**  
 Street 2 Name **MISTRAL WY**  
 Stop Condition-Street 1 **None**
