Access Compliance Report

Public Rights-of-Way

(Curb Ramps)

Intersection ID: 26692	Main Street: MANOR_HOUSE_DR	Cross Street: MISTY_HILL_LN	Location: W
ADA ID: B23F3B8B35A1	Ramp Type: Perp	Initial Pass/Fail: Fail	Overall Compliance: No
Severity Score: 1.25			
Codes/Mitigation Info/Possible Solution		Field Measurements/Component Compliance

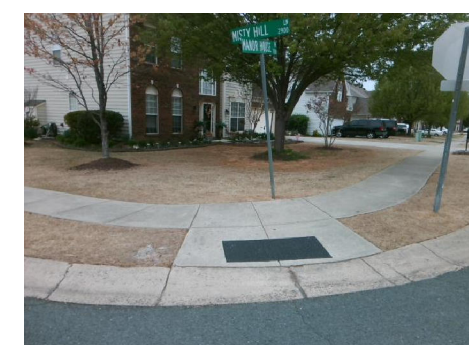
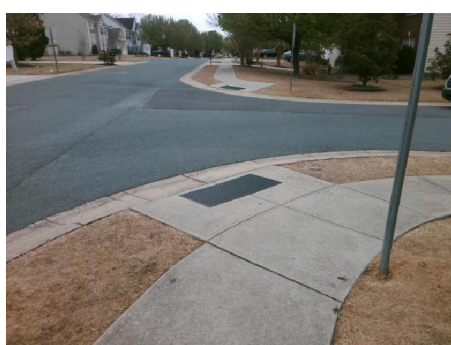
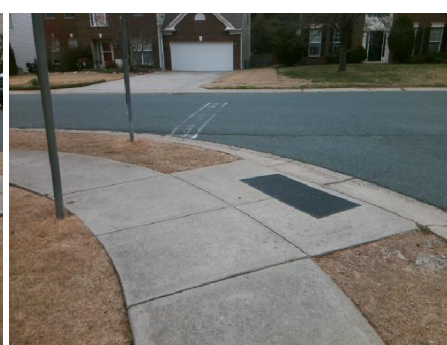
Not Found, R304.5.3

Compliance	Description	Data	Compliance	Description	Data
N/A	Ramp Length (in)	48.0	Yes	Ramp Slope (%)	5.0
Yes	Ramp Width (in)	48.0	No	Ramp XSlope (%)	2.8
N/A	Flare Type LT	N/A	N/A	Flare Type RT	N/A
N/A	Flare Slope LT (%)	N/A	N/A	Flare Slope RT (%)	N/A
N/A	Flare Traversable LT?	N/A	N/A	Flare Traversable RT?	N/A
N/A	Landing Length (in)	N/A	N/A	DWS Provided?	N/A
N/A	Landing Width (in)	N/A	N/A	DWS Contrast?	N/A
N/A	Landing Slope (%)	N/A	N/A	DWS Length (in)	N/A
N/A	Landing X Slope (%)	N/A	N/A	DWS Full Width?	N/A
N/A	Landing Curb? (Y/N)	N/A	N/A	DWS Offset (in)	N/A
N/A	Shared Landing?	N/A			
N/A	Gutter Ponding?	N/A	N/A	Gutter Slope (%)	N/A
N/A	Gutter Lip Ht (in)	N/A	N/A	Gutter X Slope (%)	N/A
N/A	Painted X Walk1?	No	N/A	Painted X Walk2?	N/A
	X Walk 1 Direction	To SW		X Walk 2 Direction	N/A
N/A	X Walk 1 Width (in)	N/A	N/A	X Walk 2 Width (in)	N/A
	X Walk 1 Slope (%)	4.1		X Walk 2 Slope (%)	N/A
	X Walk 1 X Slope (%)	4.2		X Walk 2 X Slope (%)	N/A

N/A	Ramp inside XWalk1?	N/A	N/A	Ramp inside XWalk2?	N/A
	Road Slope (%)	N/A	N/A	Clear Space?	N/A
	Road X Slope (%)	N/A	N/A	Clear Space to XWalk (in)	N/A
N/A	Any Obstructions?	N/A	N/A	Storm Grate/Utility Hazard?	N/A
	Obstruction Type			Storm Grate/Utility Type	
		N/A			N/A
		Yes		Surface Condition? (G/P)	Good

Remove & Replace Entire Ramp.
