Access Compliance Report

Public Rights-of-Way

(Curb Ramps)

Intersection ID: 31467	Main Street: BULLOCK_DR	Cross Street: SENEY_DR	Location: NE
ADA ID: B2476CA6C4EB	Ramp Type: Perp	Initial Pass/Fail: Fail	Overall Compliance: No
Severity Score: 10			
Codes/Mitigation Info/Possible Solution		Field Measurements/Component Compliance

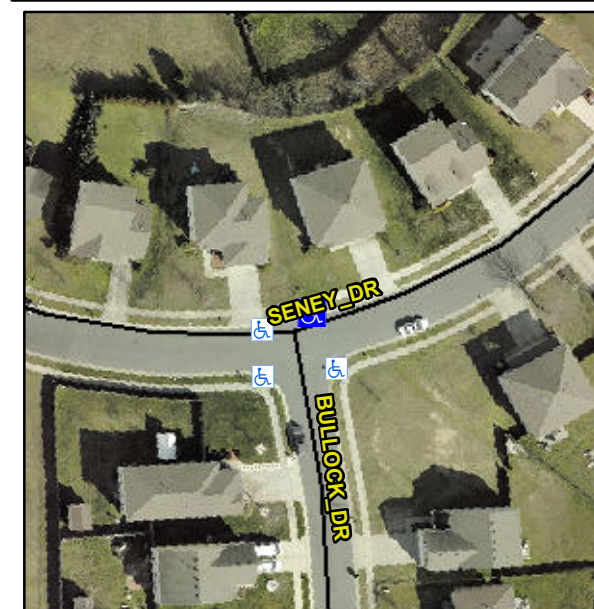
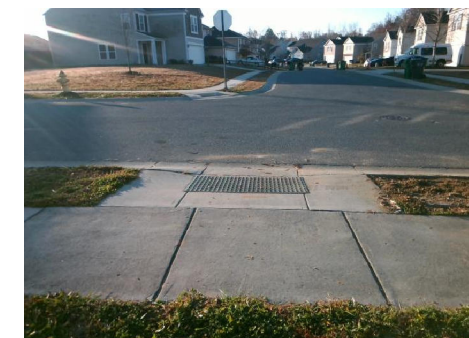
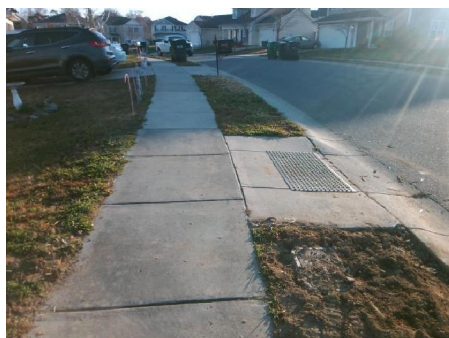
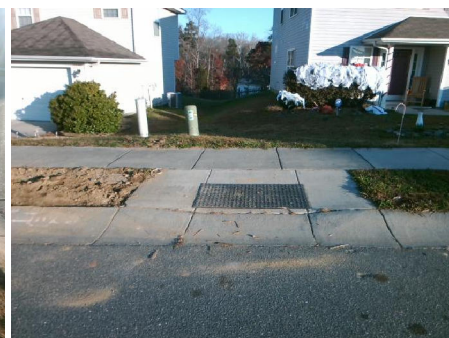
Not Found, R304.5.1

Compliance	Description	Data	Compliance	Description	Data
N/A	Ramp Length (in)	48.5	Yes	Ramp Slope (%)	7.8
No	Ramp Width (in)	43.5	Yes	Ramp XSlope (%)	3.1
N/A	Flare Type LT	N/A	N/A	Flare Type RT	N/A
N/A	Flare Slope LT (%)	N/A	N/A	Flare Slope RT (%)	N/A
N/A	Flare Traversable LT?	N/A	N/A	Flare Traversable RT?	N/A
N/A	Landing Length (in)	N/A	N/A	DWS Provided?	N/A
N/A	Landing Width (in)	N/A	N/A	DWS Contrast?	N/A
N/A	Landing Slope (%)	N/A	N/A	DWS Length (in)	N/A
N/A	Landing X Slope (%)	N/A	N/A	DWS Full Width?	N/A
N/A	Landing Curb? (Y/N)	N/A	N/A	DWS Offset (in)	N/A
N/A	Shared Landing?	N/A			
N/A	Gutter Ponding?	N/A	N/A	Gutter Slope (%)	N/A
N/A	Gutter Lip Ht (in)	N/A	N/A	Gutter X Slope (%)	N/A
N/A	Painted X Walk1?	No	N/A	Painted X Walk2?	N/A
	X Walk 1 Direction	To S		X Walk 2 Direction	N/A
N/A	X Walk 1 Width (in)	N/A	N/A	X Walk 2 Width (in)	N/A
	X Walk 1 Slope (%)	2.6		X Walk 2 Slope (%)	N/A
	X Walk 1 X Slope (%)	3.3		X Walk 2 X Slope (%)	N/A

N/A	Ramp inside XWalk1?	N/A	N/A	Ramp inside XWalk2?	N/A
	Road Slope (%)	N/A	N/A	Clear Space?	N/A
	Road X Slope (%)	N/A	N/A	Clear Space to XWalk (in)	N/A
N/A	Any Obstructions?	N/A	N/A	Storm Grate/Utility Hazard?	N/A
	Obstruction Type			Storm Grate/Utility Type	
		N/A			N/A
			Yes	Surface Condition? (G/P)	Good

Remove & Replace Entire Ramp.
