# Access Compliance Report

## Public Rights-of-Way

### (Curb Ramps)

Intersection ID: 16790	Main Street: HARTFORD_AV	Cross Street: MOULTRIE_ST	Location: NE
ADA ID: B24A7629368E	Ramp Type: PerpDiag	Initial Pass/Fail: Fail	Overall Compliance: No
		Severity Score: 10

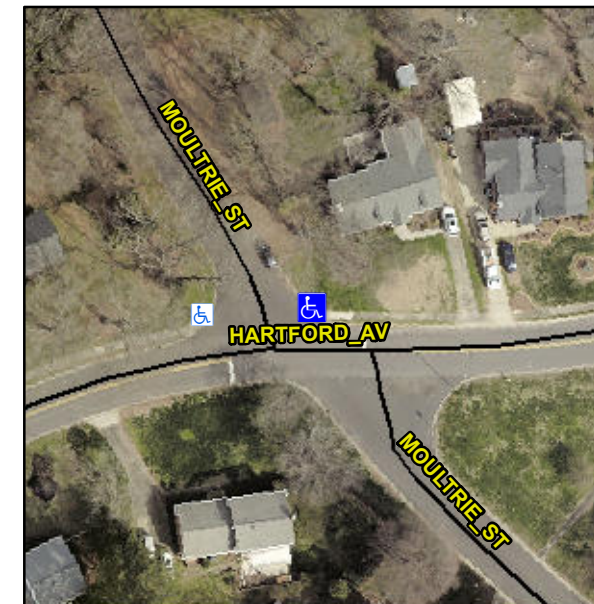
**Not Found, R304.5.1, R304.5.3**

Compliance	Description	Data	Compliance	Description	Data
N/A	Ramp Length (in)	56.0	Yes	Ramp Slope (%)	6.2
No	Ramp Width (in)	46.0	No	Ramp XSlope (%)	3.9
N/A	Flare Type LT	N/A	N/A	Flare Type RT	N/A
N/A	Flare Slope LT (%)	N/A	N/A	Flare Slope RT (%)	N/A
N/A	Flare Traversable LT?	N/A	N/A	Flare Traversable RT?	N/A
N/A	Landing Length (in)	N/A	N/A	DWS Provided?	N/A
N/A	Landing Width (in)	N/A	N/A	DWS Contrast?	N/A
N/A	Landing Slope (%)	N/A	N/A	DWS Length (in)	N/A
N/A	Landing X Slope (%)	N/A	N/A	DWS Full Width?	N/A
N/A	Landing Curb? (Y/N)	N/A	N/A	DWS Offset (in)	N/A
N/A	Shared Landing?	N/A			
N/A	Gutter Ponding?	N/A	N/A	Gutter Slope (%)	N/A
N/A	Gutter Lip Ht (in)	N/A	N/A	Gutter X Slope (%)	N/A
N/A	Painted X Walk1?	No	N/A	Painted X Walk2?	No
	X Walk 1 Direction	To W		X Walk 2 Direction	To S
N/A	X Walk 1 Width (in)	N/A	N/A	X Walk 2 Width (in)	N/A
	X Walk 1 Slope (%)	1.7		X Walk 2 Slope (%)	6.5
	X Walk 1 X Slope (%)	10.9		X Walk 2 X Slope (%)	3.7

N/A	Ramp inside XWalk1?	N/A	N/A	Ramp inside XWalk2?	N/A
	Road Slope (%)	7.4	N/A	Clear Space?	N/A
	Road X Slope (%)	8.2	N/A	Clear Space to XWalk (in)	N/A
N/A	Any Obstructions?	N/A	N/A	Storm Grate/Utility Hazard?	N/A
	Obstruction Type			Storm Grate/Utility Type	
		N/A			N/A
			Yes	Surface Condition? (G/P)	Good

**Remove & Replace Curb Ramp With Two New Directional Ramps or Equivalent.**
