Access Compliance Report

Public Rights-of-Way

(Curb Ramps)

Intersection ID: 10608	Main Street: N_DAVIDSON_ST	Cross Street: JORDAN_PL	Location: NW
ADA ID: B24B4F211EBC	Ramp Type: Perp	Initial Pass/Fail: Fail	Overall Compliance: No
Codes/Mitigation Info/Possible Solution		Field Measurements/Component Compliance	
Severity Score: 8.75

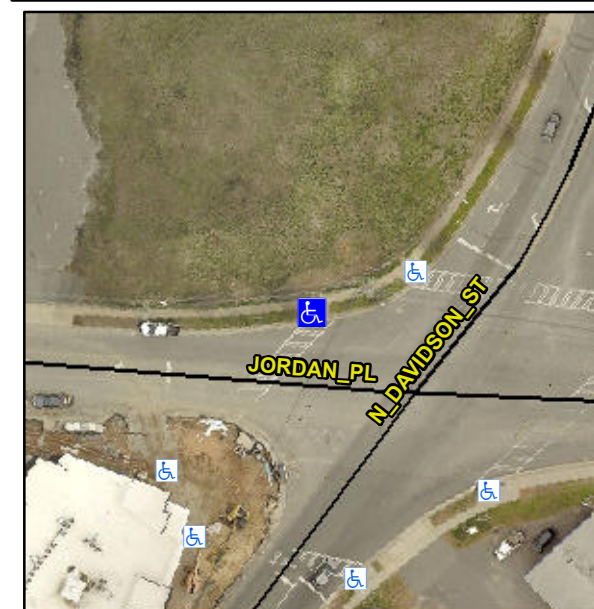
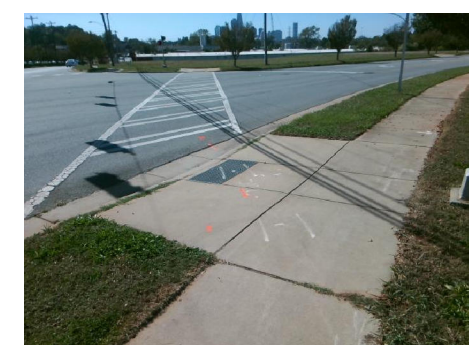
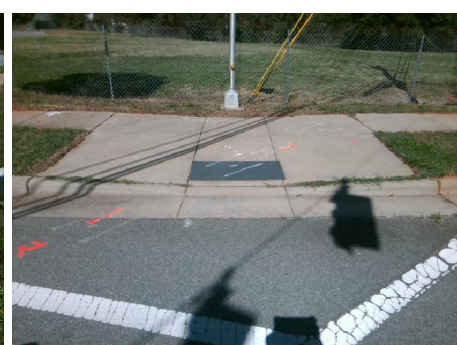
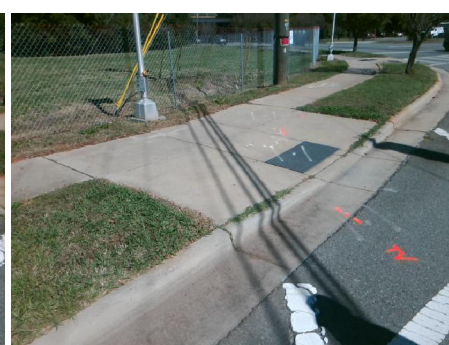
Not Found, R304.5.1

Compliance	Description	Data	Compliance	Description	Data
N/A	Ramp Length (in)	72.0	Yes	Ramp Slope (%)	6.1
No	Ramp Width (in)	47.0	Yes	Ramp XSlope (%)	1.4
N/A	Flare Type LT	N/A	N/A	Flare Type RT	N/A
N/A	Flare Slope LT (%)	N/A	N/A	Flare Slope RT (%)	N/A
N/A	Flare Traversable LT?	N/A	N/A	Flare Traversable RT?	N/A
N/A	Landing Length (in)	N/A	N/A	DWS Provided?	N/A
N/A	Landing Width (in)	N/A	N/A	DWS Contrast?	N/A
N/A	Landing Slope (%)	N/A	N/A	DWS Length (in)	N/A
N/A	Landing X Slope (%)	N/A	N/A	DWS Full Width?	N/A
N/A	Landing Curb? (Y/N)	N/A	N/A	DWS Offset (in)	N/A
N/A	Shared Landing?	N/A			
N/A	Gutter Ponding?	N/A	N/A	Gutter Slope (%)	N/A
N/A	Gutter Lip Ht (in)	N/A	N/A	Gutter X Slope (%)	N/A
N/A	Painted X Walk1?	Yes	N/A	Painted X Walk2?	N/A
	X Walk 1 Direction	To SW		X Walk 2 Direction	N/A
N/A	X Walk 1 Width (in)	149.5	N/A	X Walk 2 Width (in)	N/A
	X Walk 1 Slope (%)	1.2		X Walk 2 Slope (%)	N/A
	X Walk 1 X Slope (%)	0.7		X Walk 2 X Slope (%)	N/A

N/A	Ramp inside XWalk1?	Yes	N/A	Ramp inside XWalk2?	N/A
	Road Slope (%)	N/A	N/A	Clear Space?	N/A
	Road X Slope (%)	N/A	N/A	Clear Space to XWalk (in)	N/A
N/A	Any Obstructions?	N/A	N/A	Storm Grate/Utility Hazard?	N/A
	Obstruction Type			Storm Grate/Utility Type	
		N/A			N/A
			Yes	Surface Condition? (G/P)	Good

Possible Solutions:

Remove & Replace Entire Ramp.
