# Access Compliance Report

## Public Rights-of-Way

### (Curb Ramps)

Intersection ID: 13237	Main Street: W_PARK_AV	Cross Street: WILMORE_DR	Location: NE
ADA ID: B250C529FED4	Ramp Type: PerpDiag	Initial Pass/Fail: Fail	Overall Compliance: No
Severity Score: 13.75			
Codes/Mitigation Info/Possible Solution		Field Measurements/Component Compliance

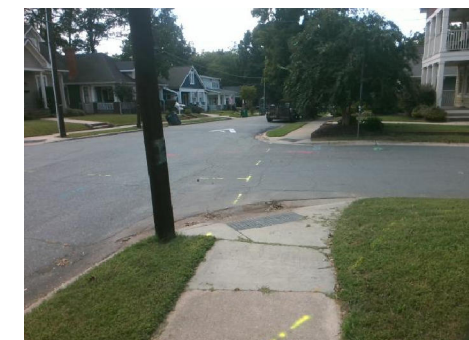
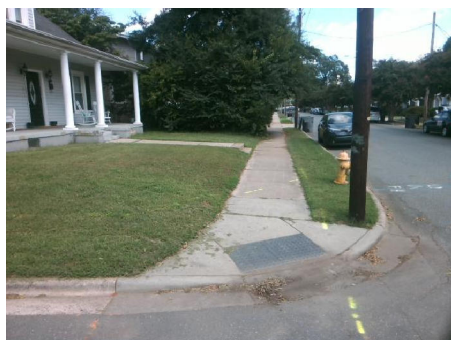
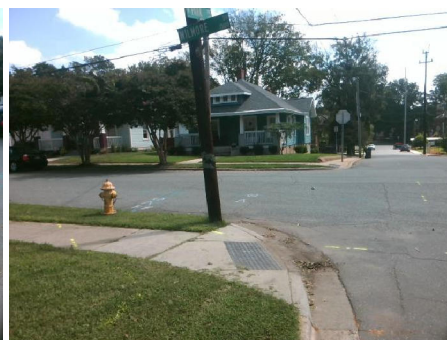
**Not Found, R304.2.2, R304.5.3**

Compliance	Description	Data	Compliance	Description	Data
N/A	Ramp Length (in)	49.0	No	Ramp Slope (%)	10.1
Yes	Ramp Width (in)	48.0	No	Ramp XSlope (%)	2.7
N/A	Flare Type LT	N/A	N/A	Flare Type RT	N/A
N/A	Flare Slope LT (%)	N/A	N/A	Flare Slope RT (%)	N/A
N/A	Flare Traversable LT?	N/A	N/A	Flare Traversable RT?	N/A
N/A	Landing Length (in)	N/A	N/A	DWS Provided?	N/A
N/A	Landing Width (in)	N/A	N/A	DWS Contrast?	N/A
N/A	Landing Slope (%)	N/A	N/A	DWS Length (in)	N/A
N/A	Landing X Slope (%)	N/A	N/A	DWS Full Width?	N/A
N/A	Landing Curb? (Y/N)	N/A	N/A	DWS Offset (in)	N/A
N/A	Shared Landing?	N/A			
N/A	Gutter Ponding?	N/A	N/A	Gutter Slope (%)	N/A
N/A	Gutter Lip Ht (in)	N/A	N/A	Gutter X Slope (%)	N/A
N/A	Painted X Walk1?	No	N/A	Painted X Walk2?	No
	X Walk 1 Direction	To SW		X Walk 2 Direction	To SE
N/A	X Walk 1 Width (in)	N/A	N/A	X Walk 2 Width (in)	N/A
	X Walk 1 Slope (%)	0.5		X Walk 2 Slope (%)	3.4
	X Walk 1 X Slope (%)	0.0		X Walk 2 X Slope (%)	0.3

N/A	Ramp inside XWalk1?	N/A	N/A	Ramp inside XWalk2?	N/A
	Road Slope (%)	1.8	N/A	Clear Space?	N/A
	Road X Slope (%)	2.3	N/A	Clear Space to XWalk (in)	N/A
N/A	Any Obstructions?	N/A	N/A	Storm Grate/Utility Hazard?	N/A
	Obstruction Type			Storm Grate/Utility Type	
		N/A			N/A
		Yes		Surface Condition? (G/P)	Good

**Remove & Replace Curb Ramp With Two New Directional Ramps or Equivalent.**
