Access Compliance Report

Public Rights-of-Way

(Curb Ramps)

Intersection ID: 11223	Main Street: CATAWBA_AV	Cross Street: HARRILL_ST	Location: SE
ADA ID: B25306F9080A	Ramp Type: Perp	Initial Pass/Fail: Fail	Overall Compliance: No
Severity Score: 13.75			
Codes/Mitigation Info/Possible Solution		Field Measurements/Component Compliance

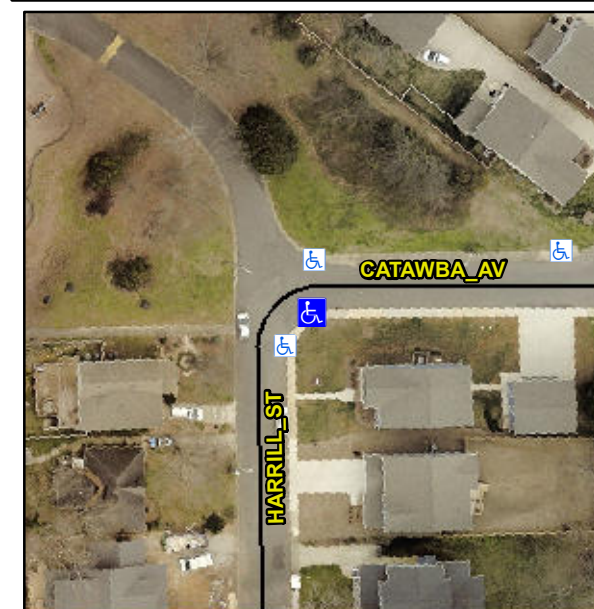
Not Found, R304.2.2, R304.5.3

Compliance	Description	Data	Compliance	Description	Data
N/A	Ramp Length (in)	53.5	No	Ramp Slope (%)	8.9
Yes	Ramp Width (in)	48.0	No	Ramp XSlope (%)	2.7
N/A	Flare Type LT	N/A	N/A	Flare Type RT	N/A
N/A	Flare Slope LT (%)	N/A	N/A	Flare Slope RT (%)	N/A
N/A	Flare Traversable LT?	N/A	N/A	Flare Traversable RT?	N/A
N/A	Landing Length (in)	N/A	N/A	DWS Provided?	N/A
N/A	Landing Width (in)	N/A	N/A	DWS Contrast?	N/A
N/A	Landing Slope (%)	N/A	N/A	DWS Length (in)	N/A
N/A	Landing X Slope (%)	N/A	N/A	DWS Full Width?	N/A
N/A	Landing Curb? (Y/N)	N/A	N/A	DWS Offset (in)	N/A
N/A	Shared Landing?	N/A			
N/A	Gutter Ponding?	N/A	N/A	Gutter Slope (%)	N/A
N/A	Gutter Lip Ht (in)	N/A	N/A	Gutter X Slope (%)	N/A
N/A	Painted X Walk1?	No	N/A	Painted X Walk2?	N/A
	X Walk 1 Direction	To N		X Walk 2 Direction	N/A
N/A	X Walk 1 Width (in)	N/A	N/A	X Walk 2 Width (in)	N/A
	X Walk 1 Slope (%)	2.3		X Walk 2 Slope (%)	N/A
	X Walk 1 X Slope (%)	0.2		X Walk 2 X Slope (%)	N/A

N/A	Ramp inside XWalk1?	N/A	N/A	Ramp inside XWalk2?	N/A
	Road Slope (%)	N/A	N/A	Clear Space?	N/A
	Road X Slope (%)	N/A	N/A	Clear Space to XWalk (in)	N/A
N/A	Any Obstructions?	N/A	N/A	Storm Grate/Utility Hazard?	N/A
	Obstruction Type			Storm Grate/Utility Type	
		N/A			N/A
			Yes	Surface Condition? (G/P)	Good

Remove & Replace Entire Ramp.
