# Access Compliance Report

## Public Rights-of-Way

### (Curb Ramps)

| Intersection ID: 2835 | Main Street: CARDINAL_POINT_RD | Cross Street: RED_CLOVER_LN | Location: W |

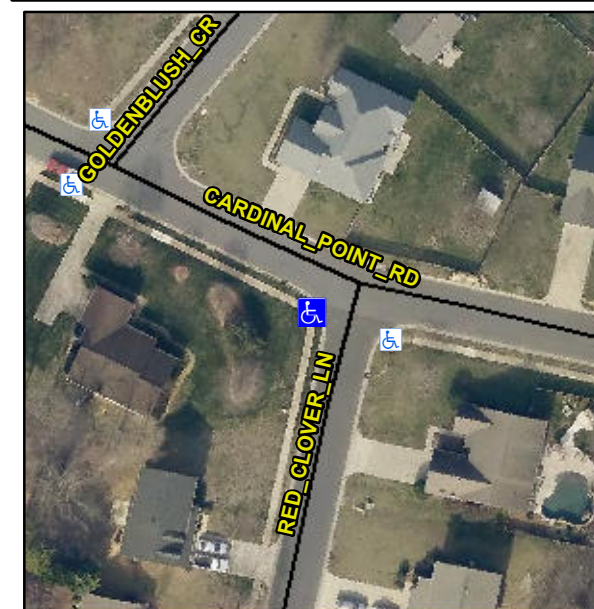
| ADA ID: B255FC2F2AC2 | Ramp Type: Perp | Initial Pass/Fail: Pass | Overall Compliance: No |
| Severity Score: 15 | | | |

**R304.2.1, R304.2.2-Perp, R304.3.2-  
Para, R305.2, R302.7.2**

| Compliance | Description | Data | Compliance | Description | Data |
|---|---|---|---|---|---|
| No | Landing Length (in) | 39.0 | Yes | DWS Provided? | Yes |
| No | Landing Slope (%) | 2.2 | Yes | DWS Length (in) | 25.5 |
| N/A | Landing Curb? (Y/N) | No | No | DWS Offset (in) | 5.0 |
| No | Gutter Lip Ht (in) | 1.5 | Yes | Gutter X Slope (%) | 1.3 |

**Remove & Replace Entire Ramp.  
Grind Gutter Lip.**

Total Cost: \$ 2050.00
