Access Compliance Report

Public Rights-of-Way

(Curb Ramps)

Intersection ID: 12680	Main Street: W_MOREHEAD_ST	Cross Street: S_MINT_ST	Location: SE
ADA ID: B25ECB910320	Ramp Type: Perp	Initial Pass/Fail: Pass	Overall Compliance: No
		Severity Score: 0

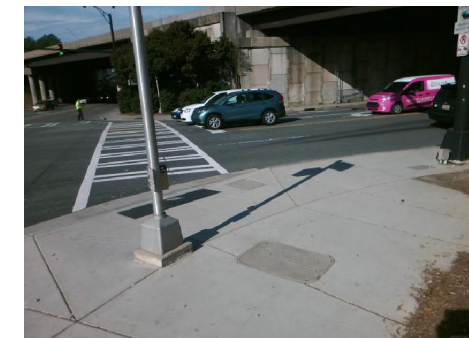
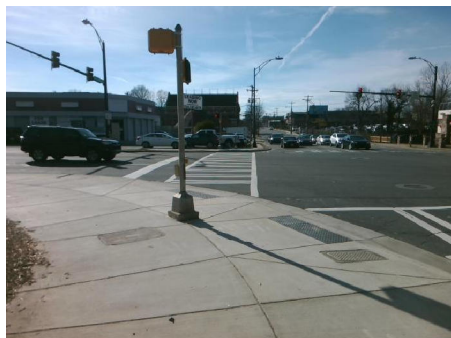
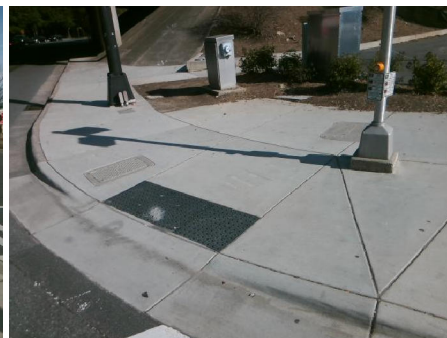
Compliance	Description	Data	Compliance	Description	Data
N/A	Ramp Length (in)	93.0	Yes	Ramp Slope (%)	5.9
Yes	Ramp Width (in)	71.0	Yes	Ramp XSlope (%)	0.0
N/A	Flare Type LT	Sloped	N/A	Flare Type RT	N/A
N/A	Flare Slope LT (%)	3.9	Yes	Flare Slope RT (%)	6.2
N/A	Flare Traversable LT?	Yes	N/A	Flare Traversable RT?	Yes
Yes	Landing Length (in)	96.0	Yes	DWS Provided?	Yes
Yes	Landing Width (in)	71.0	Yes	DWS Contrast?	Yes
Yes	Landing Slope (%)	1.7	Yes	DWS Length (in)	24.0
Yes	Landing X Slope (%)	1.9	Yes	DWS Full Width?	Yes
N/A	Landing Curb? (Y/N)	No	Yes	DWS Offset (in)	1.5
N/A	Shared Landing?	No			
Yes	Gutter Ponding?	No	Yes	Gutter Slope (%)	2.2
Yes	Gutter Lip Ht (in)	0.0	Yes	Gutter X Slope (%)	1.0
N/A	Painted X Walk1?	Yes	N/A	Painted X Walk2?	N/A
	X Walk 1 Direction	To NW		X Walk 2 Direction	N/A
N/A	X Walk 1 Width (in)	113.0	N/A	X Walk 2 Width (in)	N/A
	X Walk 1 Slope (%)	0.8		X Walk 2 Slope (%)	N/A
	X Walk 1 X Slope (%)	1.6		X Walk 2 X Slope (%)	N/A

Yes	Ramp inside XWalk1?	Yes	N/A	Ramp inside XWalk2?	N/A
	Road Slope (%)	N/A	N/A	Clear Space?	Yes
	Road X Slope (%)	N/A	N/A	Clear Space to XWalk (in)	N/A
Yes	Any Obstructions?	No	Yes	Storm Grate/Utility Hazard?	No
	Obstruction Type			Storm Grate/Utility Type	
		N/A			N/A
			Yes	Surface Condition? (G/P)	Good

Remove & Replace Entire Ramp.
