# Access Compliance Report

## Public Rights-of-Way

### (Curb Ramps)

| Intersection ID: 13736 | Main Street: CAMDEN_RD | Cross Street: E_PARK_AV | Location: SW |

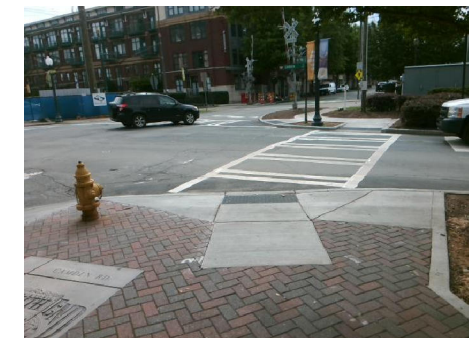
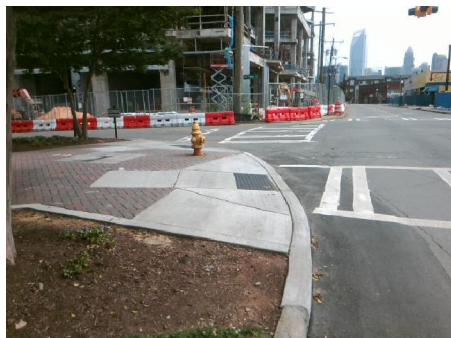
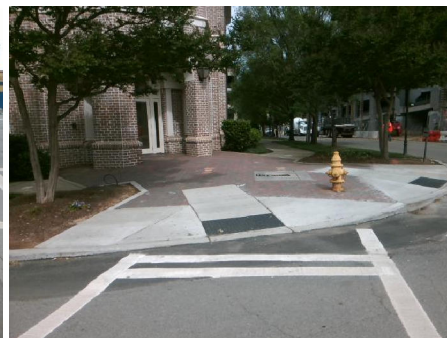
| ADA ID: B266872A0AC9 | Ramp Type: Perp | Initial Pass/Fail: Pass | Overall Compliance: No |

| Compliance | Description | Data | Compliance | Description | Data |
|---|---|---|---|---|---|
| N/A | Landing Curb? (Y/N) | No | No | DWS Offset (in) | 2.5 |

**Remove & Replace Detectable Warning System.**

**R305.2**

Total Cost: \$ 800.00
