Intersection ID: 15323	Main Street: FANNIE_CR	Cross Street: GENE_AV	Location:	E
ADA ID: B26DF94C5416	Ramp Type: ParaDiag	Initial Pass/Fail: Fail	Overall Compliance: No	Severity Score: 26.25

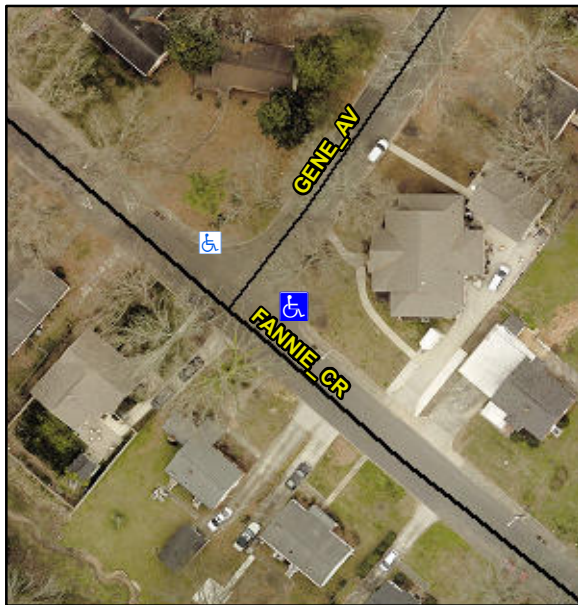
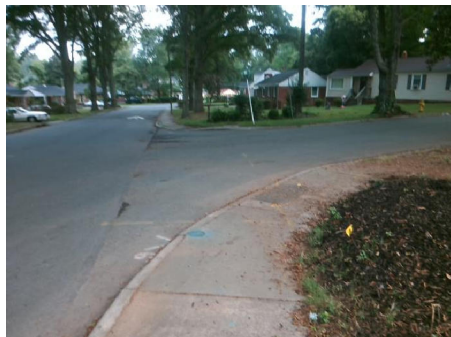
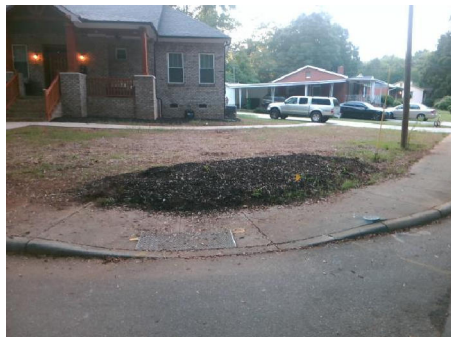
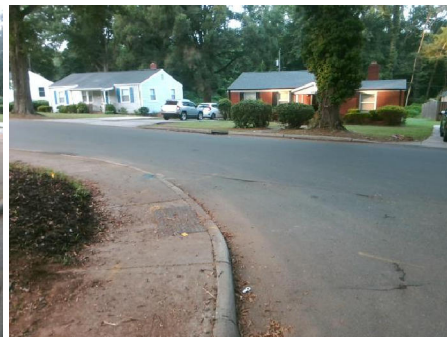
R304.3.2, R304.5.3

Compliance	Description	Data	Compliance	Description	Data
N/A	Ramp Length LT (in)	57.0	N/A	Ramp Length RT (in)	100.0
Yes	Ramp Width LT (in)	60.0	Yes	Ramp Width RT (in)	60.0
No	Ramp Slope LT (%)	12.7	Yes	Ramp Slope RT (%)	8.2
No	Ramp XSlope LT (%)	3.1	Yes	Ramp XSlope RT (%)	0.7
N/A	Landing Length (in)	N/A	N/A	DWS Provided?	N/A
N/A	Landing Width (in)	N/A	N/A	DWS Contrast?	N/A
N/A	Landing Slope (%)	N/A	N/A	DWS Length (in)	N/A
N/A	Landing X Slope (%)	N/A	N/A	DWS Full Width?	N/A
N/A	Landing Curb? (Y/N)	N/A	N/A	DWS Offset (in)	N/A
N/A	Shared Landing?	N/A			
N/A	Gutter Ponding?	N/A	N/A	Gutter Slope (%)	N/A
N/A	Gutter Lip Ht (in)	N/A	N/A	Gutter X Slope (%)	N/A
N/A	Painted X Walk1?	No	N/A	Painted X Walk2?	No
	X Walk 1 Direction	To NW		X Walk 2 Direction	To SW
N/A	X Walk 1 Width (in)	N/A	N/A	X Walk 2 Width (in)	N/A
	X Walk 1 Slope (%)	3.0		X Walk 2 Slope (%)	1.7
	X Walk 1 X Slope (%)	4.1		X Walk 2 X Slope (%)	2.5
N/A	Ramp inside XWalk1?	N/A	N/A	Ramp inside XWalk2?	N/A

Road Slope (%)	0.7	N/A	Clear Space?	N/A
	Road X Slope (%)	3.8	N/A	Clear Space to XWalk (in)	N/A
N/A	Any Obstructions?	N/A	N/A	Storm Grate/Utility Hazard?	N/A
	Obstruction Type			Storm Grate/Utility Type	
		N/A			N/A
			Yes	Surface Condition? (G/P)	Good
			N/A	Curb Slope (%)	2.0

Remove & Replace Curb Ramp With Two New Directional Ramps or Equivalent.
