# Access Compliance Report

## Public Rights-of-Way

### (Curb Ramps)

| Intersection ID: 12027 | Main Street: S SUMMIT_AV | Cross Street: W MOREHEAD_ST | Location: NW |

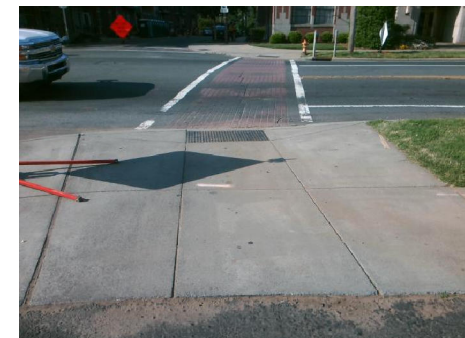
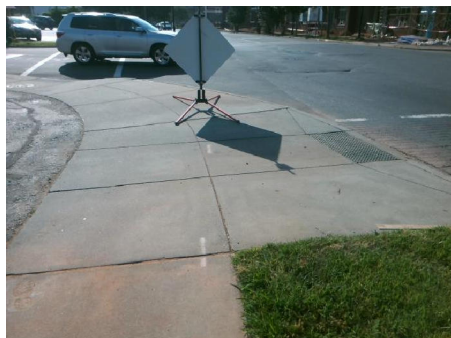
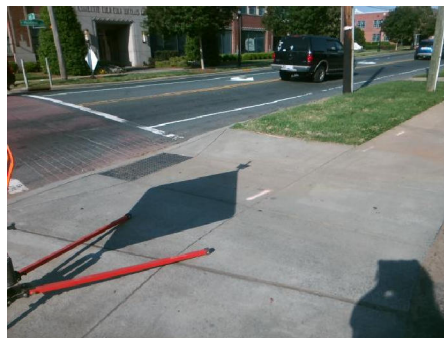
| ADA ID: B26F34ACC705 | Ramp Type: BlendTrans1 | Initial Pass/Fail: Fail | Overall Compliance: No |
| | | Severity Score: 8.75 | |

**Not Found, R304.5.1**

| Compliance | Description | Data | Compliance | Description | Data |
|---|---|---|---|---|---|
| No | Ramp Width (in) | 47.5 | Yes | BlendTrans XSlope (%) | 0.2 |
| | | | No | Curb Slope (%) | 10.4 |

**Remove & Replace Curb Ramp With Two New Directional Ramps or Equivalent.**

Total Cost: \$ 3200.00
