# Access Compliance Report

## Public Rights-of-Way

### (Curb Ramps)

Intersection ID: 50590	Main Street: GREEN_GRASS_RD	Cross Street: SITKA_CT	Location:	N
ADA ID: B272E13FAA36	Ramp Type: Perp	Initial Pass/Fail: Fail	Overall Compliance: No	Severity Score: 12.5
Codes/Mitigation Info/Possible Solution		Field Measurements/Component Compliance

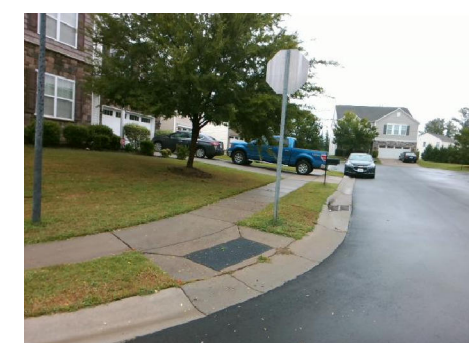
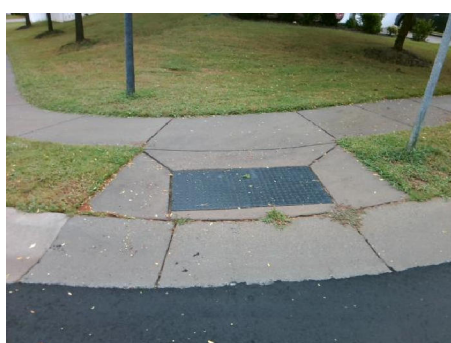
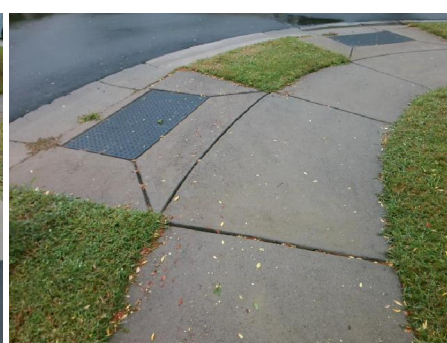
**Not Found, R304.5.3**

Compliance	Description	Data	Compliance	Description	Data
N/A	Ramp Length (in)	48.0	Yes	Ramp Slope (%)	5.9
Yes	Ramp Width (in)	48.0	No	Ramp XSlope (%)	6.2
N/A	Flare Type LT	N/A	N/A	Flare Type RT	N/A
N/A	Flare Slope LT (%)	N/A	N/A	Flare Slope RT (%)	N/A
N/A	Flare Traversable LT?	N/A	N/A	Flare Traversable RT?	N/A
N/A	Landing Length (in)	N/A	N/A	DWS Provided?	N/A
N/A	Landing Width (in)	N/A	N/A	DWS Contrast?	N/A
N/A	Landing Slope (%)	N/A	N/A	DWS Length (in)	N/A
N/A	Landing X Slope (%)	N/A	N/A	DWS Full Width?	N/A
N/A	Landing Curb? (Y/N)	N/A	N/A	DWS Offset (in)	N/A
N/A	Shared Landing?	N/A			
N/A	Gutter Ponding?	N/A	N/A	Gutter Slope (%)	N/A
N/A	Gutter Lip Ht (in)	N/A	N/A	Gutter X Slope (%)	N/A
N/A	Painted X Walk1?	No	N/A	Painted X Walk2?	N/A
	X Walk 1 Direction	To SE		X Walk 2 Direction	N/A
N/A	X Walk 1 Width (in)	N/A	N/A	X Walk 2 Width (in)	N/A
	X Walk 1 Slope (%)	0.7		X Walk 2 Slope (%)	N/A
	X Walk 1 X Slope (%)	4.2		X Walk 2 X Slope (%)	N/A

N/A	Ramp inside XWalk1?	N/A	N/A	Ramp inside XWalk2?	N/A
	Road Slope (%)	N/A	N/A	Clear Space?	N/A
	Road X Slope (%)	N/A	N/A	Clear Space to XWalk (in)	N/A
N/A	Any Obstructions?	N/A	N/A	Storm Grate/Utility Hazard?	N/A
	Obstruction Type			Storm Grate/Utility Type	
		N/A			N/A
			Yes	Surface Condition? (G/P)	Good

**Remove & Replace Entire Ramp.**
