Access Compliance Report

Public Rights-of-Way

(Curb Ramps)

Intersection ID: 5468	Main Street: N_TRYON_ST	Cross Street: J_W_CLAY_BV	Location: N
ADA ID: B28980D093CE	Ramp Type: Perp	Initial Pass/Fail: Fail	Overall Compliance: No
Severity Score: 21.25			
Codes/Mitigation Info/Possible Solution		Field Measurements/Component Compliance

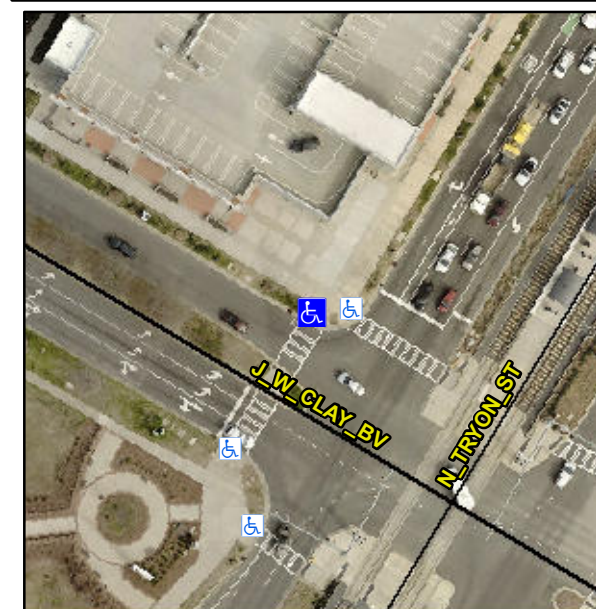
Compliance	Description	Data	Compliance	Description	Data
N/A	Ramp Length (in)	72.0	No	Ramp Slope (%)	8.9
No	Ramp Width (in)	47.0	Yes	Ramp XSlope (%)	1.1
N/A	Flare Type LT	N/A	N/A	Flare Type RT	N/A
N/A	Flare Slope LT (%)	N/A	N/A	Flare Slope RT (%)	N/A
N/A	Flare Traversable LT?	N/A	N/A	Flare Traversable RT?	N/A
N/A	Landing Length (in)	N/A	N/A	DWS Provided?	N/A
N/A	Landing Width (in)	N/A	N/A	DWS Contrast?	N/A
N/A	Landing Slope (%)	N/A	N/A	DWS Length (in)	N/A
N/A	Landing X Slope (%)	N/A	N/A	DWS Full Width?	N/A
N/A	Landing Curb? (Y/N)	N/A	N/A	DWS Offset (in)	N/A
N/A	Shared Landing?	N/A			
N/A	Gutter Ponding?	N/A	N/A	Gutter Slope (%)	N/A
N/A	Gutter Lip Ht (in)	1.5	N/A	Gutter X Slope (%)	N/A
N/A	Painted X Walk1?	No	N/A	Painted X Walk2?	N/A
	X Walk 1 Direction	To SW		X Walk 2 Direction	N/A
N/A	X Walk 1 Width (in)	N/A	N/A	X Walk 2 Width (in)	N/A
	X Walk 1 Slope (%)	2.2		X Walk 2 Slope (%)	N/A
	X Walk 1 X Slope (%)	0.4		X Walk 2 X Slope (%)	N/A

N/A	Ramp inside XWalk1?	N/A	N/A	Ramp inside XWalk2?	N/A
	Road Slope (%)	N/A	N/A	Clear Space?	N/A
	Road X Slope (%)	N/A	N/A	Clear Space to XWalk (in)	N/A
N/A	Any Obstructions?	N/A	N/A	Storm Grate/Utility Hazard?	N/A
	Obstruction Type			Storm Grate/Utility Type	
		N/A			N/A
		Yes		Surface Condition? (G/P)	Good

Possible Solutions:

Remove & Replace Entire Ramp.

R304.5.1, R304.2.2

Total Cost: \$ 1850.00
