Access Compliance Report

Public Rights-of-Way

(Curb Ramps)

Intersection ID: 49894	Main Street: ROCKY_FORD_CLUB_RD	Cross Street: RUTH_FERRELL_CT	Location: SW
ADA ID: B28A4B6FFA8D	Ramp Type: PerpDiag	Initial Pass/Fail: Fail	Overall Compliance: No
Severity Score: 21.25			
Codes/Mitigation Info/Possible Solution		Field Measurements/Component Compliance

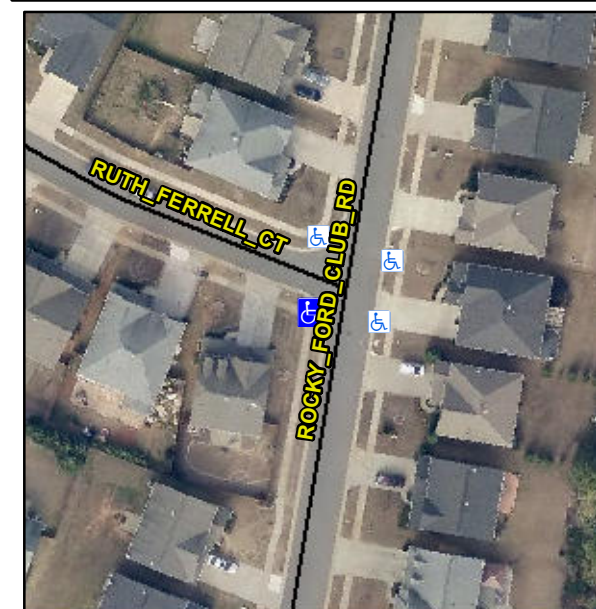
Not Found, R304.5.1, R304.5.3

Compliance	Description	Data	Compliance	Description	Data
N/A	Ramp Length (in)	71.0	Yes	Ramp Slope (%)	6.8
No	Ramp Width (in)	41.0	No	Ramp XSlope (%)	5.7
N/A	Flare Type LT	N/A	N/A	Flare Type RT	N/A
N/A	Flare Slope LT (%)	N/A	N/A	Flare Slope RT (%)	N/A
N/A	Flare Traversable LT?	N/A	N/A	Flare Traversable RT?	N/A
N/A	Landing Length (in)	N/A	N/A	DWS Provided?	N/A
N/A	Landing Width (in)	N/A	N/A	DWS Contrast?	N/A
N/A	Landing Slope (%)	N/A	N/A	DWS Length (in)	N/A
N/A	Landing X Slope (%)	N/A	N/A	DWS Full Width?	N/A
N/A	Landing Curb? (Y/N)	N/A	N/A	DWS Offset (in)	N/A
N/A	Shared Landing?	N/A			
N/A	Gutter Ponding?	N/A	N/A	Gutter Slope (%)	N/A
N/A	Gutter Lip Ht (in)	N/A	N/A	Gutter X Slope (%)	N/A
N/A	Painted X Walk1?	No	N/A	Painted X Walk2?	No
	X Walk 1 Direction	To E		X Walk 2 Direction	To N
N/A	X Walk 1 Width (in)	N/A	N/A	X Walk 2 Width (in)	N/A
	X Walk 1 Slope (%)	2.5		X Walk 2 Slope (%)	0.6
	X Walk 1 X Slope (%)	0.5		X Walk 2 X Slope (%)	2.7

N/A	Ramp inside XWalk1?	N/A	N/A	Ramp inside XWalk2?	N/A
	Road Slope (%)	2.1	N/A	Clear Space?	N/A
	Road X Slope (%)	2.1	N/A	Clear Space to XWalk (in)	N/A
N/A	Any Obstructions?	N/A	N/A	Storm Grate/Utility Hazard?	N/A
	Obstruction Type			Storm Grate/Utility Type	
		N/A			N/A
		Yes		Surface Condition? (G/P)	Good

Remove & Replace Curb Ramp With Two New Directional Ramps or Equivalent.
