# Access Compliance Report

## Public Rights-of-Way

### (Curb Ramps)

Intersection ID: 12562	Main Street: PENCE_GROVE_RD	Cross Street: SILVER_CHARM_CT	Location: SW
ADA ID: B28BA0EADA0C	Ramp Type: BlendTrans1	Initial Pass/Fail: Fail	Overall Compliance: No
Severity Score: 23.75			
Codes/Mitigation Info/Possible Solution		Field Measurements/Component Compliance

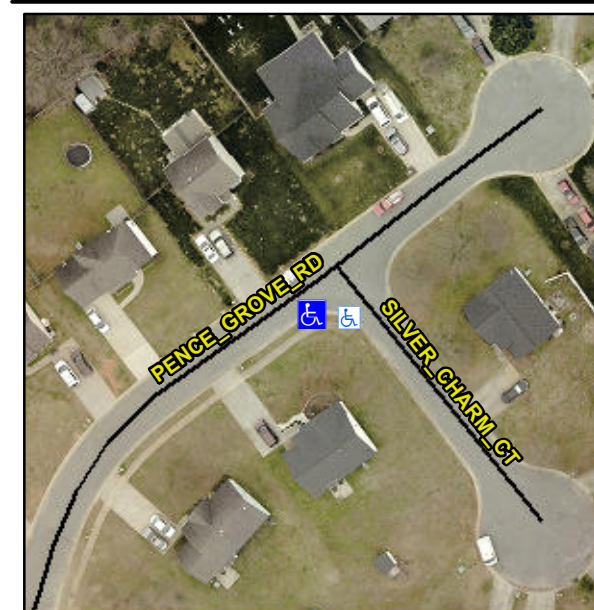
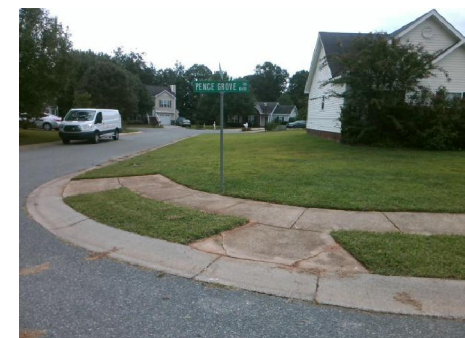
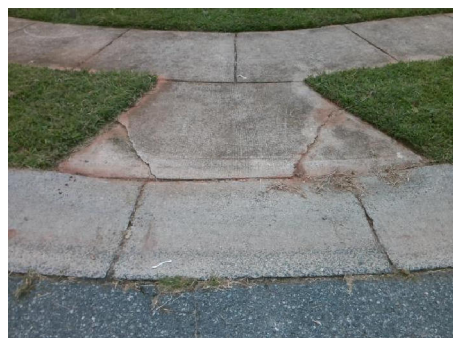
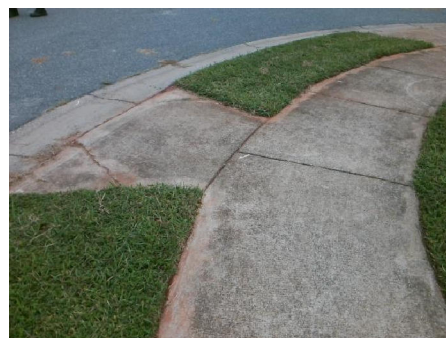
**SURFACE CRACKED**

**Not Found, R304.5.1, R302.7**

Compliance	Description	Data	Compliance	Description	Data
N/A	Ramp Length (in)	48.0	Yes	BlendTrans Slope (%)	2.7
No	Ramp Width (in)	43.5	Yes	BlendTrans XSlope (%)	0.3
N/A	Flare Type LT	N/A	N/A	Flare Type RT	N/A
N/A	Flare Slope LT (%)	N/A	N/A	Flare Slope RT (%)	N/A
N/A	Flare Traversable LT?	N/A	N/A	Flare Traversable RT?	N/A
N/A	Landing Length (in)	N/A	N/A	DWS Provided?	N/A
N/A	Landing Width (in)	N/A	N/A	DWS Contrast?	N/A
N/A	Landing Slope (%)	N/A	N/A	DWS Length (in)	N/A
N/A	Landing X Slope (%)	N/A	N/A	DWS Full Width?	N/A
N/A	Landing Curb? (Y/N)	N/A	N/A	DWS Offset (in)	N/A
N/A	Shared Landing?	N/A			
N/A	Gutter Ponding?	N/A	N/A	Gutter Slope (%)	N/A
N/A	Gutter Lip Ht (in)	N/A	N/A	Gutter X Slope (%)	N/A
N/A	Painted X Walk1?	No	N/A	Painted X Walk2?	N/A
	X Walk 1 Direction	To NW		X Walk 2 Direction	N/A
	X Walk 1 Width (in)	N/A		X Walk 2 Width (in)	N/A
	X Walk 1 Slope (%)	3.7		X Walk 2 Slope (%)	N/A
	X Walk 1 X Slope (%)	2.5		X Walk 2 X Slope (%)	N/A

N/A	Ramp inside XWalk1?	N/A	N/A	Ramp inside XWalk2?	N/A
	Road Slope (%)	2.5		Clear Space?	N/A
	Road X Slope (%)	3.7	N/A	Clear Space to XWalk (in)	N/A
N/A	Any Obstructions?	N/A	N/A	Storm Grate/Utility Hazard?	N/A
	Obstruction Type			Storm Grate/Utility Type	
		N/A			N/A
		No		Surface Condition? (G/P)	Poor
		No		Curb Slope (%)	14.5

**Remove & Replace Curb Ramp With Two New Directional Ramps or Equivalent.**
