Access Compliance Report Public Rights-of-Way (Curb Ramps)

Intersection ID: 14076 Main Street: W_TYVOLA_RD Cross Street: WEST_BV Location: SE

ADA ID: B2923387E9ED Ramp Type: MedianPerp Initial Pass/Fail: Fail Overall Compliance: No Severity Score: 25

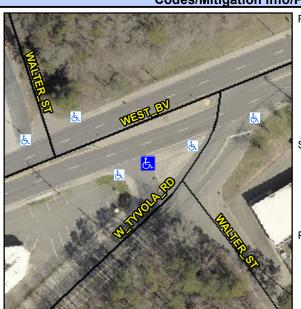
Compliance Description Data Compliance Description Data					
N/A		57.0	Yes		5.5
	Ramp Length (in)	68.0		Ramp Slope (%)	5.5 7.3
Yes	Ramp Width (in)		No N/A	Ramp XSlope (%)	N/A
N/A	Flare Clare LT (%)	N/A		Flare Type RT	
N/A	Flare Slope LT (%)	N/A	N/A	Flare Slope RT (%)	N/A
N/A	Flare Traversable LT?	N/A	N/A	Flare Traversable RT?	N/A
N/A	Landing Length (in)	N/A	N/A	DWS Provided?	N/A
N/A	Landing Width (in)	N/A	N/A	DWS Contrast?	N/A
N/A	Landing Slope (%)	N/A	N/A	DWS Length (in)	N/A
N/A	Landing X Slope (%)	N/A	N/A	DWS Full Width?	N/A
N/A	Landing Curb? (Y/N)	N/A	N/A	DWS Offset (in)	N/A
N/A	Shared Landing?	N/A			
N/A	Gutter Ponding?	N/A	N/A	Gutter Slope (%)	N/A
N/A	Gutter Lip Ht (in)	N/A	N/A	Gutter X Slope (%)	N/A
N/A	Painted X Walk1?	No	N/A	Painted X Walk2?	N/A
	X Walk 1 Direction	To W		X Walk 2 Direction	N/A
N/A	X Walk 1 Width (in)	N/A	N/A	X Walk 2 Width (in)	N/A
	X Walk 1 Slope (%)	2.0		X Walk 2 Slope (%)	N/A
	X Walk 1 X Slope (%)	9.5		X Walk 2 X Slope (%)	N/A

N/A	Ramp inside XWalk1?	N/A	N/A	Ramp inside XWalk2?	N/A
	Road Slope (%)	N/A	N/A	Clear Space?	N/A
	Road X Slope (%)	N/A	N/A	Clear Space to XWalk (in)	N/A
N/A	Any Obstructions?	N/A	N/A	Storm Grate/Utility Hazard?	N/A
	Obstruction Type			Storm Grate/Utility Type	
		N/A			N/A
			Yes	Surface Condition? (G/P)	Good

Remove & Replace Entire Ramp.

R304.5.3
