# Access Compliance Report

## Public Rights-of-Way

### (Curb Ramps)

| Intersection ID: 7131 | Main Street: N_TRYON_ST | Cross Street: ORCHARD_TRACE_LN | Location: S |

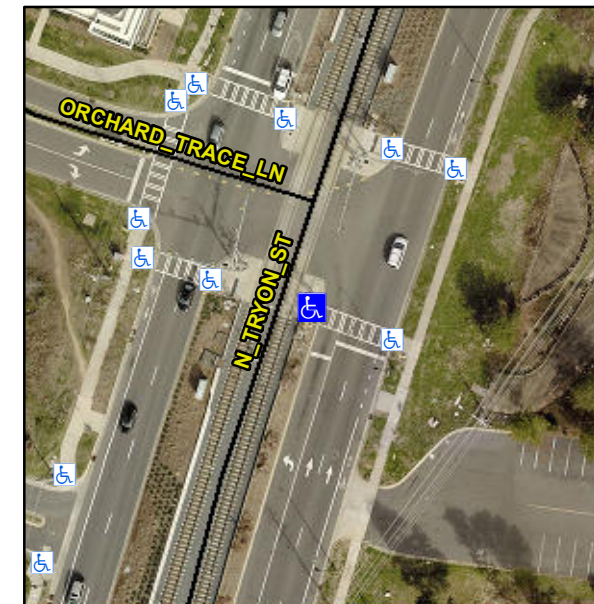
| ADA ID: B2962CD09BC3 | Ramp Type: BlendTrans2 | Initial Pass/Fail: Pass | Overall Compliance: No |
| | | Severity Score: 5 | |

| Compliance | Description | Data | Compliance | Description | Data |
|---|---|---|---|---|---|
| Yes | Flare Type | Curbed_NoWalkSurface | No | Flare Type | Curbed_WithWalkSurface |
| Yes | Gutter Lip Ht (in) | 0.0 | No | Gutter X Slope (%) | 2.5 |

Possible Solutions:

**Remove & Replace Curbed Edge.  
Remove & Replace Gutter.**

**R304.2.3, R304.5.3**

Total Cost: \$ 1050.00

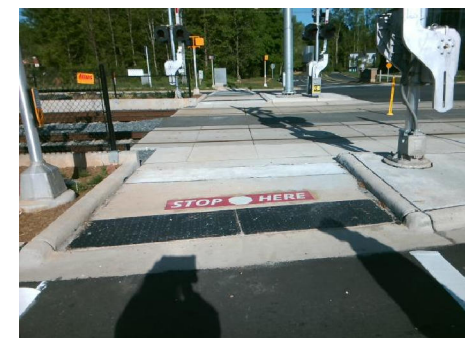
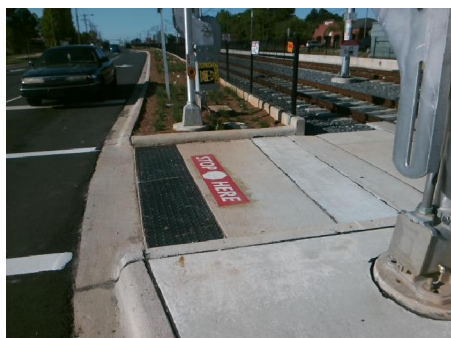
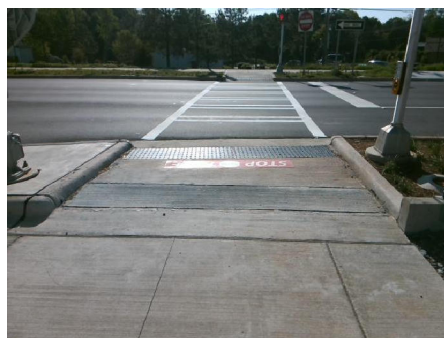
Street 1 Name N TRYON ST  
Stop Condition-Street 1 Signal  
Street 2 Name N/A  
Stop Condition-Street 2 N/A
