Access Compliance Report

Public Rights-of-Way

(Curb Ramps)

Intersection ID: 13390	Main Street: W_KINGSTON_AV	Cross Street: WILMORE_DR	Location: SE
ADA ID: B2B9A064F104	Ramp Type: PerpDiag	Initial Pass/Fail: Fail	Overall Compliance: No
Severity Score: 12.5			
Codes/Mitigation Info/Possible Solution		Field Measurements/Component Compliance

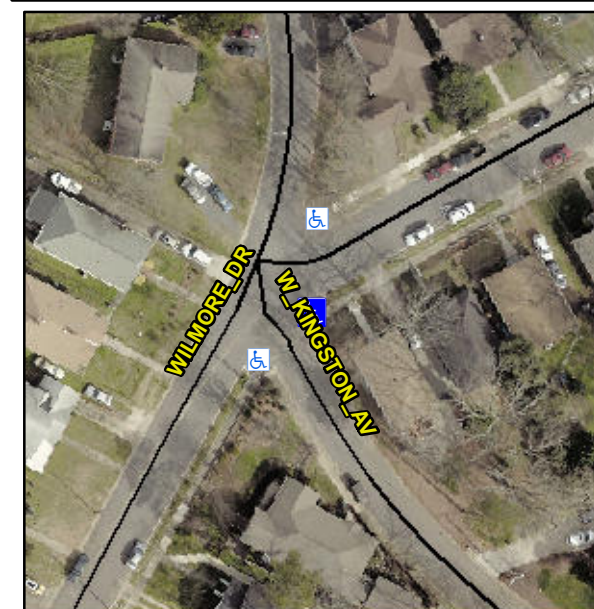
Not Found, R304.2.2

Compliance	Description	Data	Compliance	Description	Data
N/A	Ramp Length (in)	77.0	No	Ramp Slope (%)	9.8
Yes	Ramp Width (in)	48.0	Yes	Ramp XSlope (%)	1.6
N/A	Flare Type LT	N/A	N/A	Flare Type RT	N/A
N/A	Flare Slope LT (%)	N/A	N/A	Flare Slope RT (%)	N/A
N/A	Flare Traversable LT?	N/A	N/A	Flare Traversable RT?	N/A
N/A	Landing Length (in)	N/A	N/A	DWS Provided?	N/A
N/A	Landing Width (in)	N/A	N/A	DWS Contrast?	N/A
N/A	Landing Slope (%)	N/A	N/A	DWS Length (in)	N/A
N/A	Landing X Slope (%)	N/A	N/A	DWS Full Width?	N/A
N/A	Landing Curb? (Y/N)	N/A	N/A	DWS Offset (in)	N/A
N/A	Shared Landing?	N/A			
N/A	Gutter Ponding?	N/A	N/A	Gutter Slope (%)	N/A
N/A	Gutter Lip Ht (in)	1.0	N/A	Gutter X Slope (%)	N/A
N/A	Painted X Walk1?	No	N/A	Painted X Walk2?	No
	X Walk 1 Direction	To NE		X Walk 2 Direction	To SW
N/A	X Walk 1 Width (in)	N/A	N/A	X Walk 2 Width (in)	N/A
	X Walk 1 Slope (%)	9.1		X Walk 2 Slope (%)	3.4
	X Walk 1 X Slope (%)	1.4		X Walk 2 X Slope (%)	1.7

N/A	Ramp inside XWalk1?	N/A	N/A	Ramp inside XWalk2?	N/A
	Road Slope (%)	1.9	N/A	Clear Space?	N/A
	Road X Slope (%)	0.8	N/A	Clear Space to XWalk (in)	N/A
N/A	Any Obstructions?	N/A	N/A	Storm Grate/Utility Hazard?	N/A
	Obstruction Type			Storm Grate/Utility Type	
		N/A			N/A
			Yes	Surface Condition? (G/P)	Good

Possible Solutions:

Remove & Replace Curb Ramp With Two New Directional Ramps or Equivalent.
