# Access Compliance Report

## Public Rights-of-Way

### (Curb Ramps)

Intersection ID: 11545	Main Street: CARDIFF_AV	Cross Street: HILLIARD_DR	Location: NE
ADA ID: B2D4C0A4E466	Ramp Type: Perp	Initial Pass/Fail: Fail	Overall Compliance: No
Codes/Mitigation Info/Possible Solution			Severity Score: 10
			Field Measurements/Component Compliance

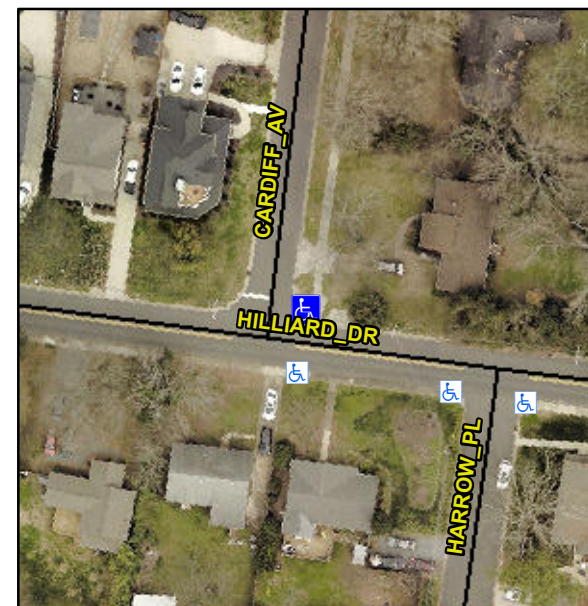
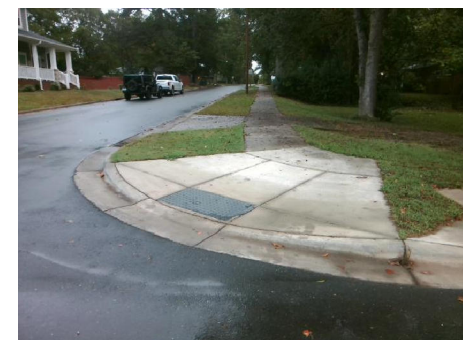
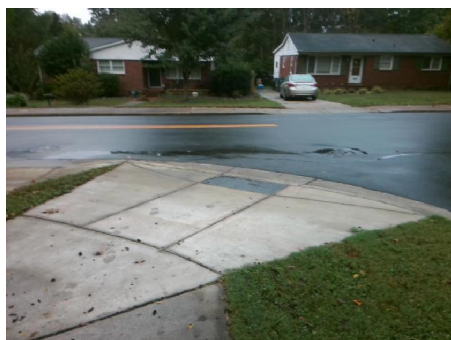
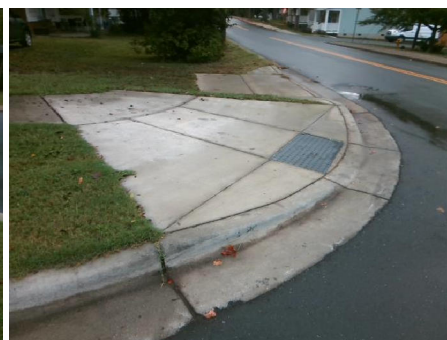
**Not Found, R304.5.1, R304.5.3**

Compliance	Description	Data	Compliance	Description	Data
N/A	Ramp Length (in)	103.0	Yes	Ramp Slope (%)	8.3
No	Ramp Width (in)	44.0	No	Ramp XSlope (%)	4.9
N/A	Flare Type LT	N/A	N/A	Flare Type RT	N/A
N/A	Flare Slope LT (%)	N/A	N/A	Flare Slope RT (%)	N/A
N/A	Flare Traversable LT?	N/A	N/A	Flare Traversable RT?	N/A
N/A	Landing Length (in)	N/A	N/A	DWS Provided?	N/A
N/A	Landing Width (in)	N/A	N/A	DWS Contrast?	N/A
N/A	Landing Slope (%)	N/A	N/A	DWS Length (in)	N/A
N/A	Landing X Slope (%)	N/A	N/A	DWS Full Width?	N/A
N/A	Landing Curb? (Y/N)	N/A	N/A	DWS Offset (in)	N/A
N/A	Shared Landing?	N/A			
N/A	Gutter Ponding?	N/A	N/A	Gutter Slope (%)	N/A
N/A	Gutter Lip Ht (in)	N/A	N/A	Gutter X Slope (%)	N/A
N/A	Painted X Walk1?	No	N/A	Painted X Walk2?	N/A
	X Walk 1 Direction	To SW		X Walk 2 Direction	N/A
N/A	X Walk 1 Width (in)	N/A	N/A	X Walk 2 Width (in)	N/A
	X Walk 1 Slope (%)	0.9		X Walk 2 Slope (%)	N/A
	X Walk 1 X Slope (%)	1.2		X Walk 2 X Slope (%)	N/A

N/A	Ramp inside XWalk1?	N/A	N/A	Ramp inside XWalk2?	N/A
	Road Slope (%)	N/A	N/A	Clear Space?	N/A
	Road X Slope (%)	N/A	N/A	Clear Space to XWalk (in)	N/A
N/A	Any Obstructions?	N/A	N/A	Storm Grate/Utility Hazard?	N/A
	Obstruction Type			Storm Grate/Utility Type	
		N/A			N/A
			Yes	Surface Condition? (G/P)	Good

**Remove & Replace Entire Ramp.**
