Access Compliance Report

Public Rights-of-Way

Intersection ID: 11262	Main Street: EASTWAY_DR	Cross Street: FRONTENAC_AV	Location: NE
ADA ID: B2DBA42CBA15	Ramp Type: Perp	Initial Pass/Fail: Fail	Overall Compliance: No
Severity Score: 13.75			
Codes/Mitigation Info/Possible Solution		Field Measurements/Component Compliance

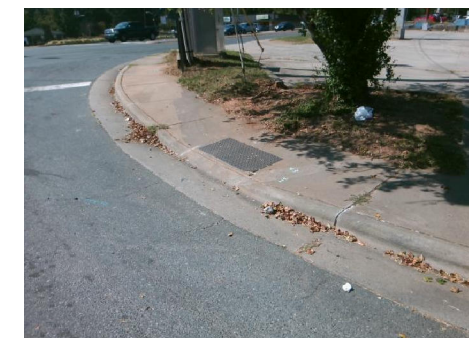
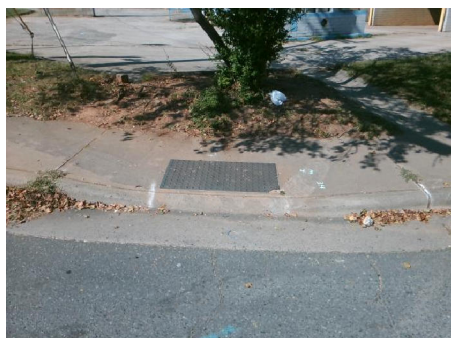
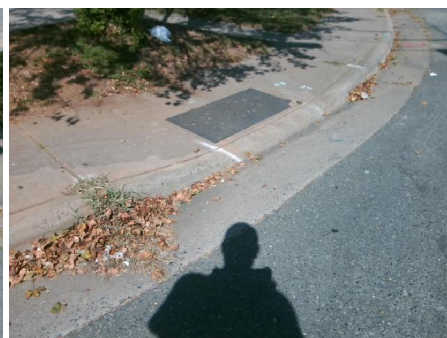
Not Found, R304.2.2, R304.5.3

Compliance	Description	Data	Compliance	Description	Data
N/A	Ramp Length (in)	59.5	No	Ramp Slope (%)	9.7
Yes	Ramp Width (in)	48.0	No	Ramp XSlope (%)	4.9
N/A	Flare Type LT	N/A	N/A	Flare Type RT	N/A
N/A	Flare Slope LT (%)	N/A	N/A	Flare Slope RT (%)	N/A
N/A	Flare Traversable LT?	N/A	N/A	Flare Traversable RT?	N/A
N/A	Landing Length (in)	N/A	N/A	DWS Provided?	N/A
N/A	Landing Width (in)	N/A	N/A	DWS Contrast?	N/A
N/A	Landing Slope (%)	N/A	N/A	DWS Length (in)	N/A
N/A	Landing X Slope (%)	N/A	N/A	DWS Full Width?	N/A
N/A	Landing Curb? (Y/N)	N/A	N/A	DWS Offset (in)	N/A
N/A	Shared Landing?	N/A			
N/A	Gutter Ponding?	N/A	N/A	Gutter Slope (%)	N/A
N/A	Gutter Lip Ht (in)	N/A	N/A	Gutter X Slope (%)	N/A
N/A	Painted X Walk1?	No	N/A	Painted X Walk2?	N/A
	X Walk 1 Direction	To SE		X Walk 2 Direction	N/A
N/A	X Walk 1 Width (in)	N/A	N/A	X Walk 2 Width (in)	N/A
	X Walk 1 Slope (%)	3.4		X Walk 2 Slope (%)	N/A
	X Walk 1 X Slope (%)	4.3		X Walk 2 X Slope (%)	N/A

N/A	Ramp inside XWalk1?	N/A	N/A	Ramp inside XWalk2?	N/A
	Road Slope (%)	N/A	N/A	Clear Space?	N/A
	Road X Slope (%)	N/A	N/A	Clear Space to XWalk (in)	N/A
N/A	Any Obstructions?	N/A	N/A	Storm Grate/Utility Hazard?	N/A
	Obstruction Type			Storm Grate/Utility Type	
		N/A			N/A
			Yes	Surface Condition? (G/P)	Good

Possible Solutions:

Remove & Replace Entire Ramp.
