## Access Compliance Report Public Rights-of-Way (Curb Ramps)

Intersection ID: 22032 Main Street: NATIONS\_FORD\_RD Cross Street: RAMBLELAKE\_RD Location: SW

ADA ID: B2E26E06EF1F Ramp Type: PerpDiag Initial Pass/Fail: Fail Overall Compliance: No Severity Score: 12.5

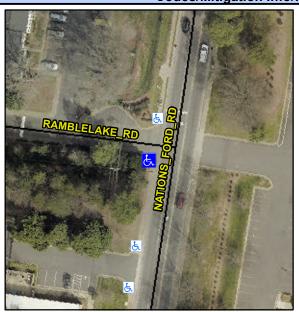
Not Found, R304.2.2

| Field Measurements/Component Compliance | | | | | |
|---|---|---|---|---|---|
| N/A | Ramp Length (in) | 25.0 | No | Ramp Slope (%) | 8.8 |

Remove & Replace Curb Ramp With Two New Directional Ramps or Equivalent.

Total Cost: \$ 3200.00
