Access Compliance Report

Public Rights-of-Way

(Curb Ramps)

Intersection ID: 24503	Main Street: BRUFF_CT	Cross Street: SAINTFIELD_PL	Location: E
ADA ID: B2E62CCE304A	Ramp Type: BlendTrans1	Initial Pass/Fail: Fail	Overall Compliance: No
		Severity Score: 8.75

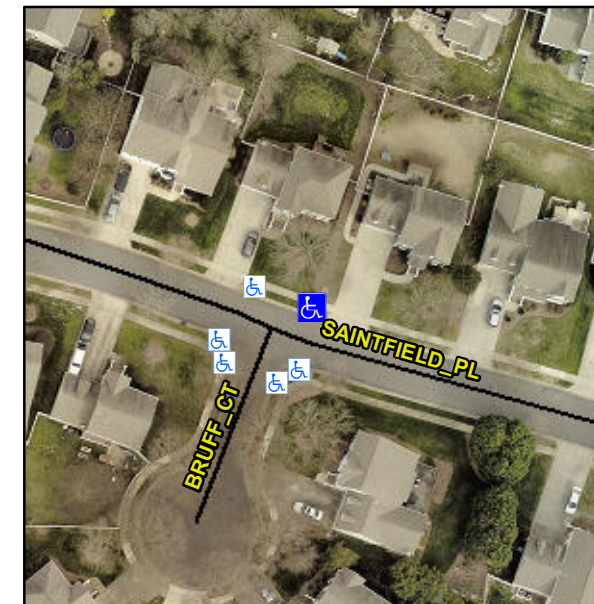
Not Found, R304.5.1

Compliance	Description	Data	Compliance	Description	Data
N/A	Ramp Length (in)	48.0	Yes	BlendTrans Slope (%)	4.2
No	Ramp Width (in)	40.0	Yes	BlendTrans XSlope (%)	0.6
N/A	Flare Type LT	N/A	N/A	Flare Type RT	N/A
N/A	Flare Slope LT (%)	N/A	N/A	Flare Slope RT (%)	N/A
N/A	Flare Traversable LT?	N/A	N/A	Flare Traversable RT?	N/A
N/A	Landing Length (in)	N/A	N/A	DWS Provided?	N/A
N/A	Landing Width (in)	N/A	N/A	DWS Contrast?	N/A
N/A	Landing Slope (%)	N/A	N/A	DWS Length (in)	N/A
N/A	Landing X Slope (%)	N/A	N/A	DWS Full Width?	N/A
N/A	Landing Curb? (Y/N)	N/A	N/A	DWS Offset (in)	N/A
N/A	Shared Landing?	N/A			
N/A	Gutter Ponding?	N/A	N/A	Gutter Slope (%)	N/A
N/A	Gutter Lip Ht (in)	N/A	N/A	Gutter X Slope (%)	N/A
N/A	Painted X Walk1?	No	N/A	Painted X Walk2?	N/A
	X Walk 1 Direction	To S		X Walk 2 Direction	N/A
	X Walk 1 Width (in)	N/A		X Walk 2 Width (in)	N/A
	X Walk 1 Slope (%)	2.1		X Walk 2 Slope (%)	N/A
	X Walk 1 X Slope (%)	0.5		X Walk 2 X Slope (%)	N/A

N/A	Ramp inside XWalk1?	N/A	N/A	Ramp inside XWalk2?	N/A
	Road Slope (%)	0.5		Clear Space?	N/A
	Road X Slope (%)	2.1	N/A	Clear Space to XWalk (in)	N/A
N/A	Any Obstructions?	N/A	N/A	Storm Grate/Utility Hazard?	N/A
	Obstruction Type			Storm Grate/Utility Type	
		N/A			N/A
			Yes	Surface Condition? (G/P)	Good
			No	Curb Slope (%)	15.5

Possible Solutions:

Remove & Replace Curb Ramp With Two New Directional Ramps or Equivalent.
