# Access Compliance Report

## Public Rights-of-Way

### (Curb Ramps)

Intersection ID: 10035582	Main Street: REAMES_RD	Cross Street: N/A	Location: W
ADA ID: B2F38202DE67	Ramp Type: Perp	Initial Pass/Fail: Fail	Overall Compliance: No
Severity Score: 8.75			
Codes/Mitigation Info/Possible Solution		Field Measurements/Component Compliance

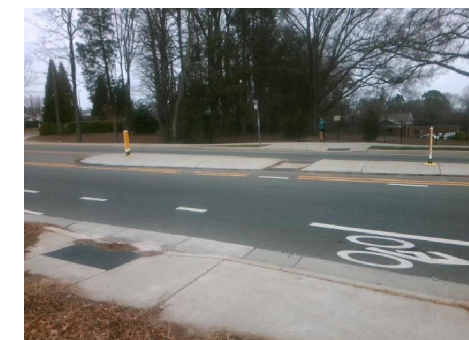
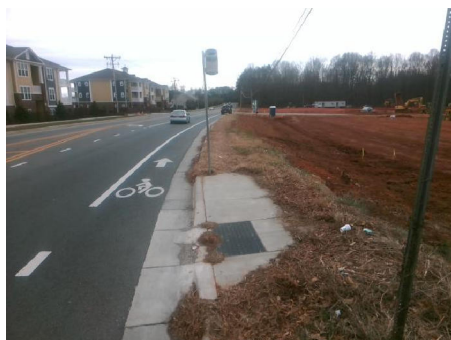
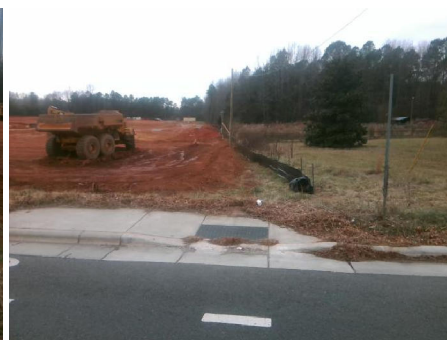
**Not Found, R304.5.1**

Compliance	Description	Data	Compliance	Description	Data
N/A	Ramp Length (in)	71.5	Yes	Ramp Slope (%)	5.9
No	Ramp Width (in)	46.5	Yes	Ramp XSlope (%)	1.2
N/A	Flare Type LT	N/A	N/A	Flare Type RT	N/A
N/A	Flare Slope LT (%)	N/A	N/A	Flare Slope RT (%)	N/A
N/A	Flare Traversable LT?	N/A	N/A	Flare Traversable RT?	N/A
N/A	Landing Length (in)	N/A	N/A	DWS Provided?	N/A
N/A	Landing Width (in)	N/A	N/A	DWS Contrast?	N/A
N/A	Landing Slope (%)	N/A	N/A	DWS Length (in)	N/A
N/A	Landing X Slope (%)	N/A	N/A	DWS Full Width?	N/A
N/A	Landing Curb? (Y/N)	N/A	N/A	DWS Offset (in)	N/A
N/A	Shared Landing?	N/A			
N/A	Gutter Ponding?	N/A	N/A	Gutter Slope (%)	N/A
N/A	Gutter Lip Ht (in)	N/A	N/A	Gutter X Slope (%)	N/A
N/A	Painted X Walk1?	No	N/A	Painted X Walk2?	N/A
	X Walk 1 Direction	To E		X Walk 2 Direction	N/A
N/A	X Walk 1 Width (in)	N/A	N/A	X Walk 2 Width (in)	N/A
	X Walk 1 Slope (%)	2.4		X Walk 2 Slope (%)	N/A
	X Walk 1 X Slope (%)	0.2		X Walk 2 X Slope (%)	N/A

N/A	Ramp inside XWalk1?	N/A	N/A	Ramp inside XWalk2?	N/A
	Road Slope (%)	N/A	N/A	Clear Space?	N/A
	Road X Slope (%)	N/A	N/A	Clear Space to XWalk (in)	N/A
N/A	Any Obstructions?	N/A	N/A	Storm Grate/Utility Hazard?	N/A
	Obstruction Type			Storm Grate/Utility Type	
		N/A			N/A
			Yes	Surface Condition? (G/P)	Good

**Remove & Replace Entire Ramp.**

Total Cost: \$ 1850.00
