# Access Compliance Report

## Public Rights-of-Way

### (Curb Ramps)

Intersection ID: N/A	Main Street: PROVIDENCE COUNTRY CLUB DR	Cross Street: WAVERLY WALK AV	Location: SW
ADA ID: B2FB218DD615	Ramp Type: Directional	Initial Pass/Fail: Fail	Overall Compliance: No
Severity Score: 13.75			
Codes/Mitigation Info/Possible Solution		Field Measurements/Component Compliance

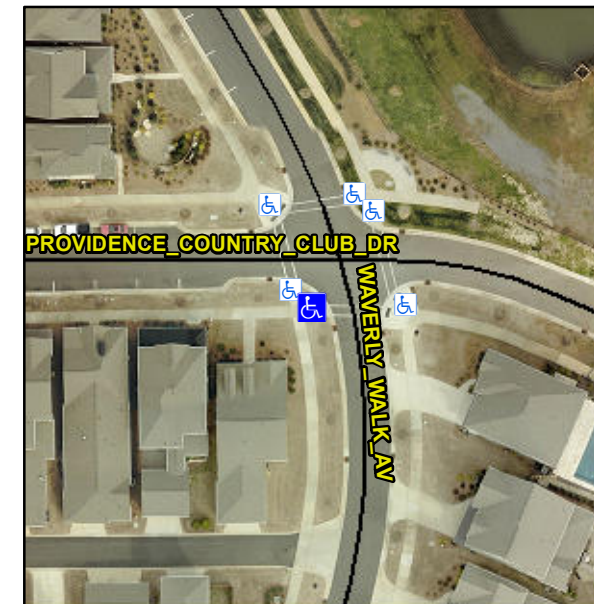
Compliance	Description	Data	Compliance	Description	Data
N/A	Ramp Length (in)	132.0	N/A	Grade Break?	N/A
Yes	Ramp Width (in)	66.0	N/A	Grade Break Slope (%)	0.0
No	Ramp Slope (%)	9.0	N/A	Grade Break XSlope (%)	0.0
No	Ramp XSlope (%)	2.1			
N/A	Flare Type LT	N/A	N/A	Flare Type RT	N/A
N/A	Flare Slope LT (%)	N/A	N/A	Flare Slope RT (%)	0.0
N/A	Flare Traversable LT?	N/A	N/A	Flare Traversable RT?	N/A
N/A	Landing Length (in)	0.0	N/A	DWS Provided?	N/A
N/A	Landing Width (in)	0.0	N/A	DWS Contrast?	N/A
N/A	Landing Slope (%)	0.0	N/A	DWS Length (in)	N/A
N/A	Landing X Slope (%)	0.0	N/A	DWS Full Width?	N/A
N/A	Landing Curb? (Y/N)	N/A	N/A	DWS Offset LT (in)	N/A
N/A	Shared Landing?	N/A	N/A	DWS Offset RT (in)	N/A
N/A	Gutter Ponding?	0.0	N/A	Gutter Slope (%)	N/A
N/A	Gutter Lip Ht (in)	0.0	N/A	Gutter X Slope (%)	N/A
N/A	Painted X Walk1?	No		Road Slope (%)	1.1
	X Walk 1 Direction	To E		Road X Slope (%)	0.2
	X Walk 1 Width (in)	N/A		Clear Space?	N/A

X Walk 1 Slope (%)	1.1	N/A	Clear Space to XWalk (in)	N/A
	X Walk 1 X Slope (%)	0.2	N/A	Storm Grate/Utility Hazard?	N/A
N/A	Ramp inside XWalk1?	N/A		Storm Grate/Utility Type	
N/A	Any Obstructions?	N/A			N/A
	Obstruction Type		Yes	Surface Condition? (G/P)	Good
			N/A	Curb Slope (%)	6.3

Possible Solutions:

**Remove & Replace Entire Ramp.**

**R304.2.2, R304.5.3**
