## **Access Compliance Report Public Rights-of-Way** (Curb Ramps)

Intersection ID: 21122 Main Street: SHARON VIEW RD Cross Street: WINDING\_BROOK\_RD Location: SW ADA ID: B30B37B67320 Ramp Type: PerpDiag Initial Pass/Fail: Fail **Overall Compliance: No Severity Score:** 25

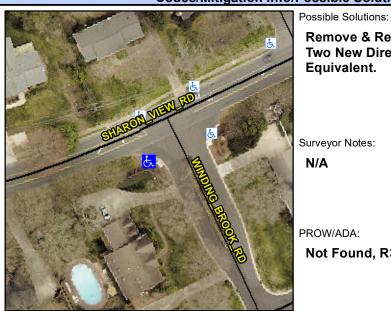
Not Found, R304.2.2

Field Measurements/Component Compliance					
Compliance Description		Data	Comp	liance Description	Data
N/A	Ramp Length (in)	66.5	No	Ramp Slope (%)	13.6
Yes	Ramp Width (in)	48.0	Yes	Ramp XSlope (%)	0.3
N/A	Flare Type LT	N/A	N/A	Flare Type RT	N/A
N/A	Flare Slope LT (%)	N/A	N/A	Flare Slope RT (%)	N/A
N/A	Flare Traversable LT?	N/A	N/A	Flare Traversable RT?	N/A
N/A	Landing Length (in)	N/A	N/A	DWS Provided?	N/A
N/A	Landing Width (in)	N/A	N/A	DWS Contrast?	N/A
N/A	Landing Slope (%)	N/A	N/A	DWS Length (in)	N/A
N/A	Landing X Slope (%)	N/A	N/A	DWS Full Width?	N/A
N/A	Landing Curb? (Y/N)	N/A	N/A	DWS Offset (in)	N/A
N/A	Shared Landing?	N/A			
N/A	Gutter Ponding?	N/A	N/A	Gutter Slope (%)	N/A
N/A	Gutter Lip Ht (in)	N/A	N/A	Gutter X Slope (%)	N/A
N/A	Painted X Walk1?	No	N/A	Painted X Walk2?	No
	X Walk 1 Direction	To E		X Walk 2 Direction	To N
N/A	X Walk 1 Width (in)	N/A	N/A	X Walk 2 Width (in)	N/A
	X Walk 1 Slope (%)	1.2		X Walk 2 Slope (%)	3.8

X Walk 1 X Slope (%)	1.8		X Walk 2 X Slope (%)	0.8
N/A	Ramp inside XWalk1?	N/A	N/A	Ramp inside XWalk2?	N/A
	Road Slope (%)	2.6	N/A	Clear Space?	N/A
	Road X Slope (%)	1.4	N/A	Clear Space to XWalk (in)	N/A
N/A	Any Obstructions?	N/A	N/A	Storm Grate/Utility Hazard?	N/A
	Obstruction Type			Storm Grate/Utility Type	
		N/A			N/A
			Yes	Surface Condition? (G/P)	Good
	TO REPORT S

Remove & Replace Curb Ramp With **Two New Directional Ramps or** Equivalent.
