Access Compliance Report

Public Rights-of-Way

(Curb Ramps)

Intersection ID: 10014519	Main Street: UNIVERSITY_POINTE_BV	Cross Street: N/A	Location: SW
ADA ID: B31510E996A6	Ramp Type: Perp	Initial Pass/Fail: Fail	Overall Compliance: No
Severity Score: 10			
Codes/Mitigation Info/Possible Solution		Field Measurements/Component Compliance

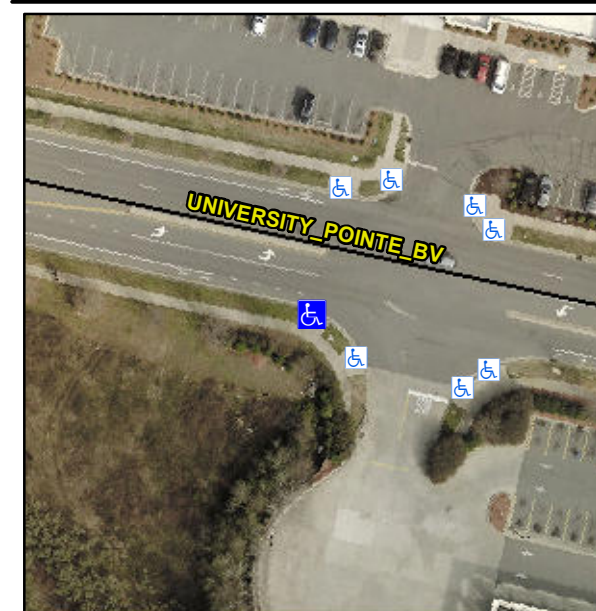
Not Found, R304.5.1

Compliance	Description	Data	Compliance	Description	Data
N/A	Ramp Length (in)	95.0	Yes	Ramp Slope (%)	7.2
No	Ramp Width (in)	47.0	Yes	Ramp XSlope (%)	4.2
N/A	Flare Type LT	N/A	N/A	Flare Type RT	N/A
N/A	Flare Slope LT (%)	N/A	N/A	Flare Slope RT (%)	N/A
N/A	Flare Traversable LT?	N/A	N/A	Flare Traversable RT?	N/A
N/A	Landing Length (in)	N/A	N/A	DWS Provided?	N/A
N/A	Landing Width (in)	N/A	N/A	DWS Contrast?	N/A
N/A	Landing Slope (%)	N/A	N/A	DWS Length (in)	N/A
N/A	Landing X Slope (%)	N/A	N/A	DWS Full Width?	N/A
N/A	Landing Curb? (Y/N)	N/A	N/A	DWS Offset (in)	N/A
N/A	Shared Landing?	N/A			
N/A	Gutter Ponding?	N/A	N/A	Gutter Slope (%)	N/A
N/A	Gutter Lip Ht (in)	N/A	N/A	Gutter X Slope (%)	N/A
N/A	Painted X Walk1?	No	N/A	Painted X Walk2?	N/A
	X Walk 1 Direction	To N		X Walk 2 Direction	N/A
N/A	X Walk 1 Width (in)	N/A	N/A	X Walk 2 Width (in)	N/A
	X Walk 1 Slope (%)	1.4		X Walk 2 Slope (%)	N/A
	X Walk 1 X Slope (%)	6.9		X Walk 2 X Slope (%)	N/A

N/A	Ramp inside XWalk1?	N/A	N/A	Ramp inside XWalk2?	N/A
	Road Slope (%)	N/A	N/A	Clear Space?	N/A
	Road X Slope (%)	N/A	N/A	Clear Space to XWalk (in)	N/A
N/A	Any Obstructions?	N/A	N/A	Storm Grate/Utility Hazard?	N/A
	Obstruction Type			Storm Grate/Utility Type	
		N/A			N/A
			Yes	Surface Condition? (G/P)	Good

Remove & Replace Entire Ramp.

Total Cost: \$ 1850.00
