Access Compliance Report Public Rights-of-Way (Curb Ramps)

Intersection ID: 5704 Main Street: W_W_T_HARRIS_BV Cross Street: N_TRYON_ST Location: W **Overall Compliance: No** ADA ID: B31C89481015 Ramp Type: Perp Initial Pass/Fail: Fail **Severity Score:** 12.5

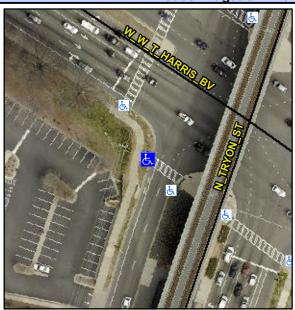
| Possible Solutions: | Cor |
|---|---|
| Not Found, R304.2.2 | N/A |

| Field Measurements/Component Compliance | | | | | | | | |
|---|---|---|---|---|---|---|--|--|
| N/A | Ramp Length (in) | 123.0 | No | Ramp | Slope (%) | 8.9 | | |

| Possible Solutions: | Cor |
|---|---|
| Remove & Replace Entire Ramp. | N/A |
