Access Compliance Report

Public Rights-of-Way

(Curb Ramps)

Intersection ID: 48571	Main Street: DAPPLE_CT	Cross Street: SALAMANDER_RUN_LN	Location: W
ADA ID: B333F80A8290	Ramp Type: Perp	Initial Pass/Fail: Fail	Overall Compliance: No
Severity Score: 22.5			
Codes/Mitigation Info/Possible Solution		Field Measurements/Component Compliance

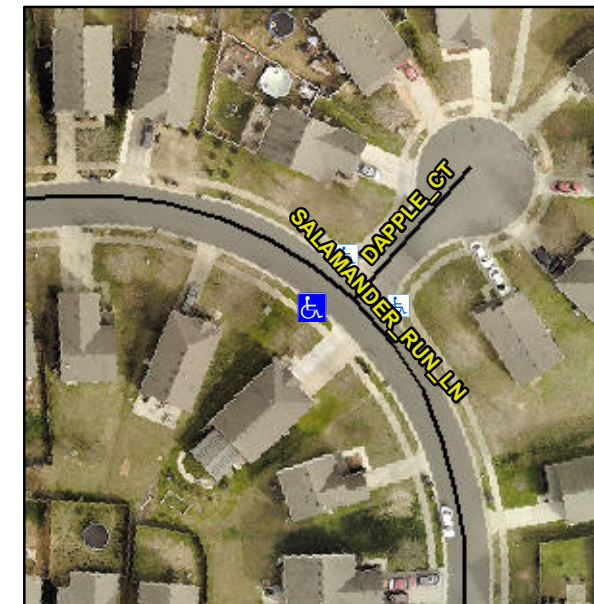
Not Found, R304.5.1, R304.2.2, R304.5.3

Compliance	Description	Data	Compliance	Description	Data
N/A	Ramp Length (in)	47.5	No	Ramp Slope (%)	10.2
No	Ramp Width (in)	47.5	No	Ramp XSlope (%)	2.3
N/A	Flare Type LT	N/A	N/A	Flare Type RT	N/A
N/A	Flare Slope LT (%)	N/A	N/A	Flare Slope RT (%)	N/A
N/A	Flare Traversable LT?	N/A	N/A	Flare Traversable RT?	N/A
N/A	Landing Length (in)	N/A	N/A	DWS Provided?	N/A
N/A	Landing Width (in)	N/A	N/A	DWS Contrast?	N/A
N/A	Landing Slope (%)	N/A	N/A	DWS Length (in)	N/A
N/A	Landing X Slope (%)	N/A	N/A	DWS Full Width?	N/A
N/A	Landing Curb? (Y/N)	N/A	N/A	DWS Offset (in)	N/A
N/A	Shared Landing?	N/A			
N/A	Gutter Ponding?	N/A	N/A	Gutter Slope (%)	N/A
N/A	Gutter Lip Ht (in)	N/A	N/A	Gutter X Slope (%)	N/A
N/A	Painted X Walk1?	No	N/A	Painted X Walk2?	N/A
	X Walk 1 Direction	To NE		X Walk 2 Direction	N/A
N/A	X Walk 1 Width (in)	N/A	N/A	X Walk 2 Width (in)	N/A
	X Walk 1 Slope (%)	1.2		X Walk 2 Slope (%)	N/A
	X Walk 1 X Slope (%)	0.6		X Walk 2 X Slope (%)	N/A

N/A	Ramp inside XWalk1?	N/A	N/A	Ramp inside XWalk2?	N/A
	Road Slope (%)	N/A	N/A	Clear Space?	N/A
	Road X Slope (%)	N/A	N/A	Clear Space to XWalk (in)	N/A
N/A	Any Obstructions?	N/A	N/A	Storm Grate/Utility Hazard?	N/A
	Obstruction Type			Storm Grate/Utility Type	
		N/A			N/A
			Yes	Surface Condition? (G/P)	Good

Possible Solutions:

Remove & Replace Entire Ramp.
