# Access Compliance Report

## Public Rights-of-Way

### (Curb Ramps)

| Intersection ID: 14340 | Main Street: KENILWORTH_AV | Cross Street: GREENWOOD_CLIFF | Location: | N |

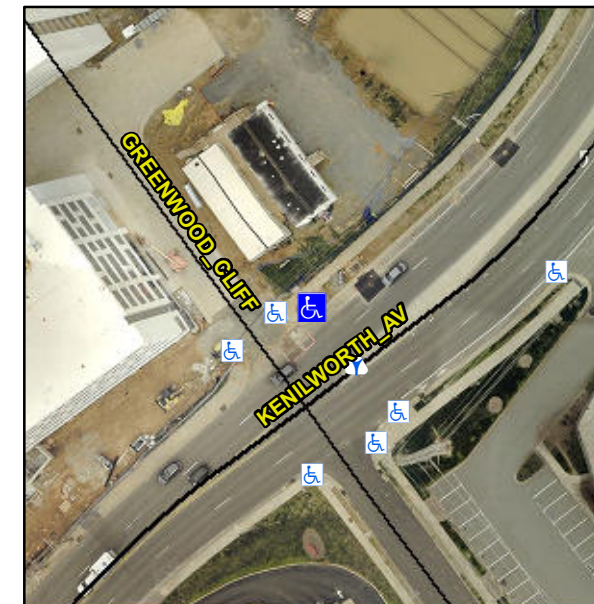
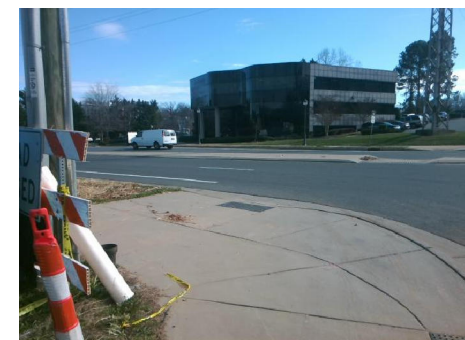
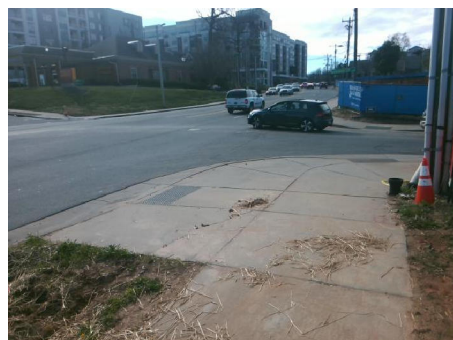
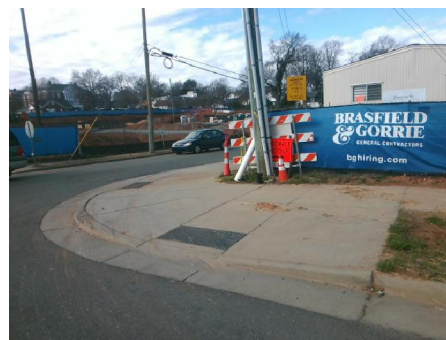
**Not Found, R304.5.3, R305.2, R302.7.2**

| Compliance | Description | Data | Compliance | Description | Data |
|---|---|---|---|---|---|
| No | Landing X Slope (%) | 2.1 | Yes | DWS Full Width? | Yes |
| N/A | Landing Curb? (Y/N) | No | No | DWS Offset (in) | 5.0 |
| No | Gutter Lip Ht (in) | 0.3 | Yes | Gutter X Slope (%) | 0.6 |
| | | | No | Curb Slope (%) | 11.9 |

**Remove & Replace Curb Ramp With Two New Directional Ramps or Equivalent.**

Total Cost: \$ 3200.00
