# Access Compliance Report

## Public Rights-of-Way

### (Curb Ramps)

Intersection ID: 12792	Main Street: E_HILL_ST	Cross Street: S_TRYON_ST	Location: S
ADA ID: B33885EFD945	Ramp Type: Perp	Initial Pass/Fail: Fail	Overall Compliance: No
Severity Score: 13.75			
Codes/Mitigation Info/Possible Solution		Field Measurements/Component Compliance

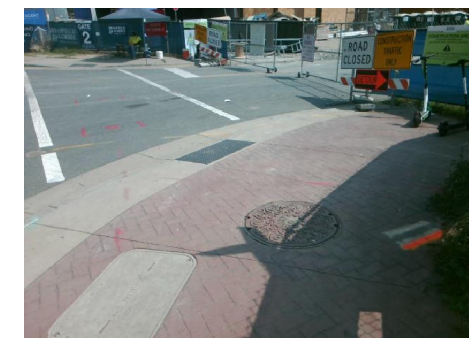
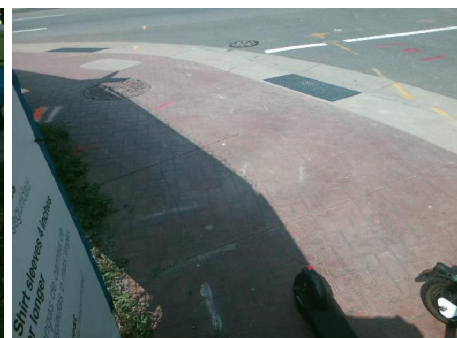
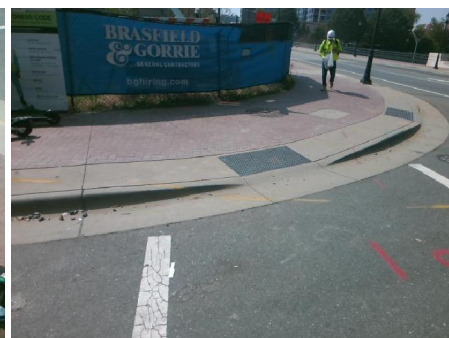
Compliance	Description	Data	Compliance	Description	Data
N/A	Ramp Length (in)	76.0	No	Ramp Slope (%)	10.0
Yes	Ramp Width (in)	48.0	Yes	Ramp XSlope (%)	3.7
N/A	Flare Type LT	N/A	N/A	Flare Type RT	N/A
N/A	Flare Slope LT (%)	N/A	N/A	Flare Slope RT (%)	N/A
N/A	Flare Traversable LT?	N/A	N/A	Flare Traversable RT?	N/A
N/A	Landing Length (in)	N/A	N/A	DWS Provided?	N/A
N/A	Landing Width (in)	N/A	N/A	DWS Contrast?	N/A
N/A	Landing Slope (%)	N/A	N/A	DWS Length (in)	N/A
N/A	Landing X Slope (%)	N/A	N/A	DWS Full Width?	N/A
N/A	Landing Curb? (Y/N)	N/A	N/A	DWS Offset (in)	N/A
N/A	Shared Landing?	N/A			
N/A	Gutter Ponding?	N/A	N/A	Gutter Slope (%)	N/A
N/A	Gutter Lip Ht (in)	N/A	N/A	Gutter X Slope (%)	N/A
N/A	Painted X Walk1?	Yes	N/A	Painted X Walk2?	N/A
	X Walk 1 Direction	To NE		X Walk 2 Direction	N/A
N/A	X Walk 1 Width (in)	131.0	N/A	X Walk 2 Width (in)	N/A
	X Walk 1 Slope (%)	2.2		X Walk 2 Slope (%)	N/A
	X Walk 1 X Slope (%)	6.1		X Walk 2 X Slope (%)	N/A

N/A	Ramp inside XWalk1?	Yes	N/A	Ramp inside XWalk2?	N/A
	Road Slope (%)	N/A	N/A	Clear Space?	N/A
	Road X Slope (%)	N/A	N/A	Clear Space to XWalk (in)	N/A
N/A	Any Obstructions?	N/A	N/A	Storm Grate/Utility Hazard?	N/A
	Obstruction Type			Storm Grate/Utility Type	
		N/A			N/A
			Yes	Surface Condition? (G/P)	Good

**Remove & Replace Entire Ramp.**
