Access Compliance Report

Public Rights-of-Way

(Curb Ramps)

Intersection ID: 48071	Main Street: STUB_ST	Cross Street: RED_VULCAN_CT	Location: SW
ADA ID: B33BC82621F5	Ramp Type: BlendTrans1	Initial Pass/Fail: Fail	Overall Compliance: No
		Severity Score: 8.75

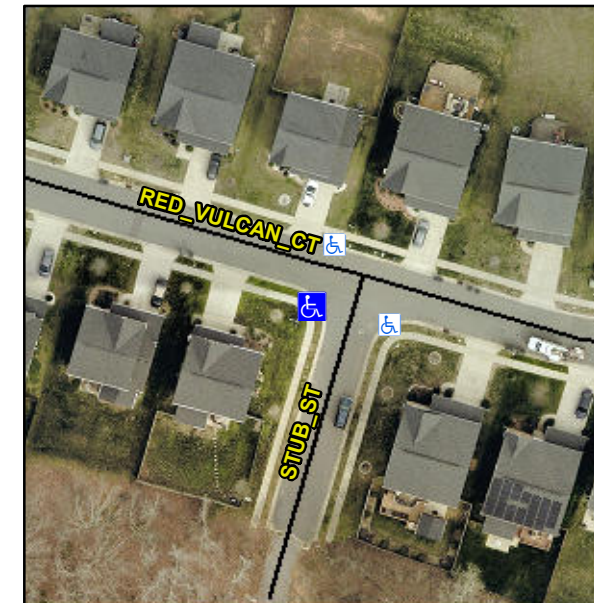
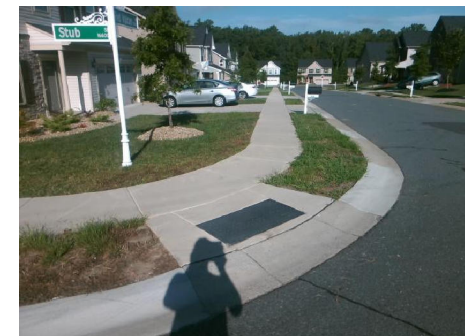
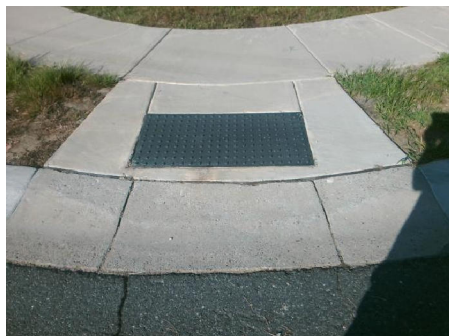
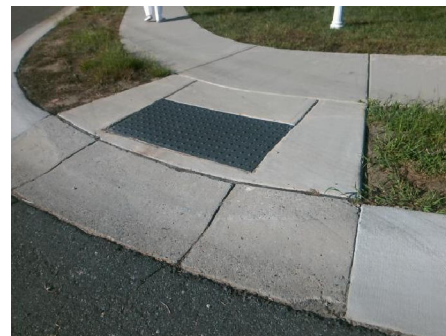
Not Found, R304.5.1

Compliance	Description	Data	Compliance	Description	Data
N/A	Ramp Length (in)	46.5	Yes	BlendTrans Slope (%)	2.6
No	Ramp Width (in)	47.0	Yes	BlendTrans XSlope (%)	1.6
N/A	Flare Type LT	N/A	N/A	Flare Type RT	N/A
N/A	Flare Slope LT (%)	N/A	N/A	Flare Slope RT (%)	N/A
N/A	Flare Traversable LT?	N/A	N/A	Flare Traversable RT?	N/A
N/A	Landing Length (in)	N/A	N/A	DWS Provided?	N/A
N/A	Landing Width (in)	N/A	N/A	DWS Contrast?	N/A
N/A	Landing Slope (%)	N/A	N/A	DWS Length (in)	N/A
N/A	Landing X Slope (%)	N/A	N/A	DWS Full Width?	N/A
N/A	Landing Curb? (Y/N)	N/A	N/A	DWS Offset (in)	N/A
N/A	Shared Landing?	N/A			
N/A	Gutter Ponding?	N/A	N/A	Gutter Slope (%)	N/A
N/A	Gutter Lip Ht (in)	N/A	N/A	Gutter X Slope (%)	N/A
N/A	Painted X Walk1?	No	N/A	Painted X Walk2?	No
	X Walk 1 Direction	To E		X Walk 2 Direction	To N
	X Walk 1 Width (in)	N/A		X Walk 2 Width (in)	N/A
	X Walk 1 Slope (%)	4.8		X Walk 2 Slope (%)	5.8
	X Walk 1 X Slope (%)	5.1		X Walk 2 X Slope (%)	4.5

N/A	Ramp inside XWalk1?	N/A	N/A	Ramp inside XWalk2?	N/A
	Road Slope (%)	0.4		Clear Space?	N/A
	Road X Slope (%)	6.9	N/A	Clear Space to XWalk (in)	N/A
N/A	Any Obstructions?	N/A	N/A	Storm Grate/Utility Hazard?	N/A
	Obstruction Type			Storm Grate/Utility Type	
		N/A			N/A
			Yes	Surface Condition? (G/P)	Good
			No	Curb Slope (%)	35.9

Remove & Replace Curb Ramp With Two New Directional Ramps or Equivalent.
