# Access Compliance Report

## Public Rights-of-Way

| Intersection ID: 13576 | Main Street: WATSON_DR | Cross Street: WEST_BV | Location: NE |
| ADA ID: B3457DC07194 | Ramp Type: PerpDiag | Initial Pass/Fail: Fail | Overall Compliance: No |

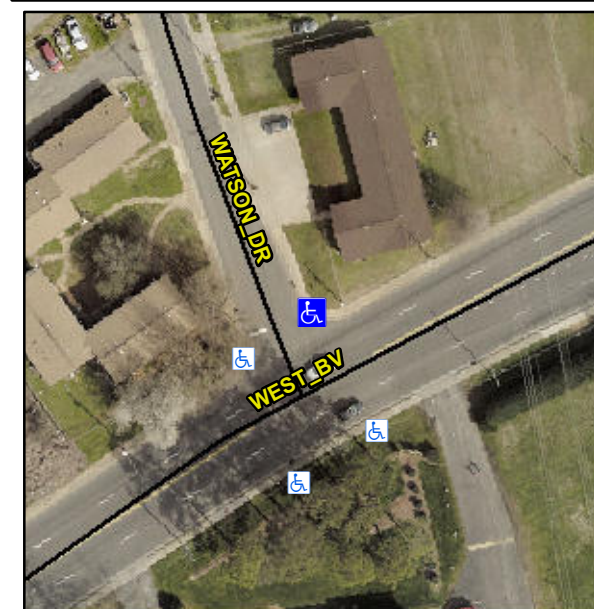
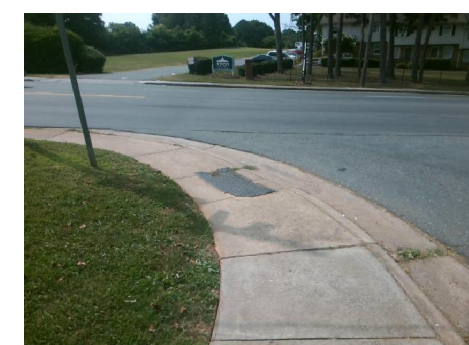
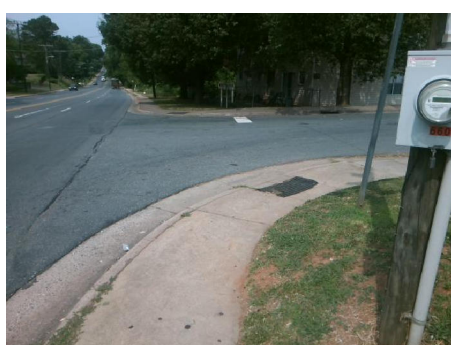
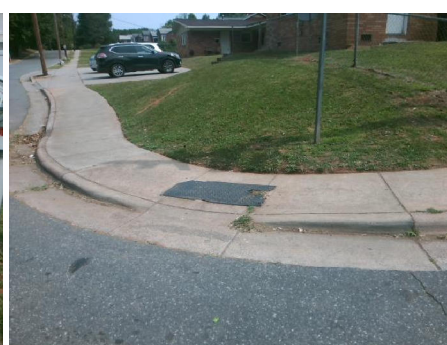
**Not Found, R304.5.1, R304.5.3**

| Compliance | Description | Data | Compliance | Description | Data |
|---|---|---|---|---|---|
| N/A | Ramp Length (in) | 48.0 | Yes | Ramp Slope (%) | 5.1 |
| No | Ramp Width (in) | 37.0 | No | Ramp XSlope (%) | 5.8 |

**Remove & Replace Curb Ramp With Two New Directional Ramps or Equivalent.**
