## Access Compliance Report Public Rights-of-Way (Curb Ramps)

Intersection ID: 24329 Main Street: GARBOW\_CT Cross Street: MIROW\_PL Location: E

ADA ID: B349D994A084 Ramp Type: PerpDiag Initial Pass/Fail: Fail Overall Compliance: No Severity Score: 12.5

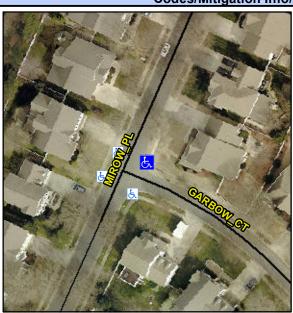
Not Found, R304.2.2

Comp	liance Description	Data	Comp	liance	Description	Data
N/A	Ramp Length (in)	45.0	No	Ramp	Slope (%)	10.4
Yes	Ramp Width (in)	48.0	Yes	Ramp	1.4	
N/A	Flare Type LT	N/A	N/A	Flare	Flare Type RT	
N/A	Flare Slope LT (%)	N/A	N/A	Flare	Slope RT (%)	N/A
N/A	Flare Traversable LT?	N/A	N/A	Flare	Traversable RT?	N/A
N/A	Landing Length (in)	N/A	N/A	DWS	Provided?	N/A
N/A	Landing Width (in)	N/A	N/A	DWS	Contrast?	N/A
N/A	Landing Slope (%)	N/A	N/A	DWS	Length (in)	N/A
N/A	Landing X Slope (%)	N/A	N/A	DWS	Full Width?	N/A
N/A	Landing Curb? (Y/N)	N/A	N/A	DWS	Offset (in)	N/A
N/A	Shared Landing?	N/A				
N/A	Gutter Ponding?	N/A	N/A	Gutte	r Slope (%)	N/A
N/A	Gutter Lip Ht (in)	N/A	N/A	Gutte	r X Slope (%)	N/A
N/A	Painted X Walk1?	No	N/A	Paint	ed X Walk2?	No
	X Walk 1 Direction	To NW		X Wa	lk 2 Direction	To SW
N/A	X Walk 1 Width (in)	N/A	N/A	X Wa	lk 2 Width (in)	N/A
	X Walk 1 Slope (%)	1.1		X Wa	lk 2 Slope (%)	0.6
	X Walk 1 X Slope (%)	1.8		X Wa	lk 2 X Slope (%)	0.3

N/A	Ramp inside XWalk1?	N/A	N/A	Ramp	inside XWalk2?	N/A
	Road Slope (%)	1.3	N/A	Clear	Space?	N/A
	Road X Slope (%)	0.1	N/A	Clear	Space to XWalk (in)	N/A
N/A	Any Obstructions?	N/A	N/A	Storm	Grate/Utility Hazard?	N/A
	Obstruction Type			Storm	n Grate/Utility Type	
		N/A				N/A

Remove & Replace Curb Ramp With Two New Directional Ramps or Equivalent.
