# Access Compliance Report

## Public Rights-of-Way

### (Curb Ramps)

Intersection ID: 10037212	Main Street: SANDY_ROCK_PL	Cross Street: N/A	Location: NW
ADA ID: B349F70098DE	Ramp Type: Perp	Initial Pass/Fail: Fail	Overall Compliance: No
		Severity Score: 12.5	
Codes/Mitigation Info/Possible Solution		Field Measurements/Component Compliance

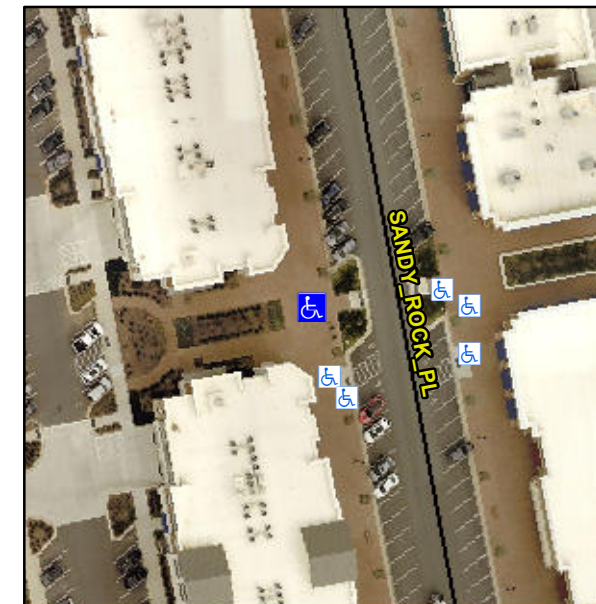
**Not Found, R304.2.2**

Compliance	Description	Data	Compliance	Description	Data
N/A	Ramp Length (in)	83.0	No	Ramp Slope (%)	8.7
Yes	Ramp Width (in)	95.0	Yes	Ramp XSlope (%)	1.9
N/A	Flare Type LT	N/A	N/A	Flare Type RT	N/A
N/A	Flare Slope LT (%)	N/A	N/A	Flare Slope RT (%)	N/A
N/A	Flare Traversable LT?	N/A	N/A	Flare Traversable RT?	N/A
N/A	Landing Length (in)	N/A	N/A	DWS Provided?	N/A
N/A	Landing Width (in)	N/A	N/A	DWS Contrast?	N/A
N/A	Landing Slope (%)	N/A	N/A	DWS Length (in)	N/A
N/A	Landing X Slope (%)	N/A	N/A	DWS Full Width?	N/A
N/A	Landing Curb? (Y/N)	N/A	N/A	DWS Offset (in)	N/A
N/A	Shared Landing?	N/A			
N/A	Gutter Ponding?	N/A	N/A	Gutter Slope (%)	N/A
N/A	Gutter Lip Ht (in)	N/A	N/A	Gutter X Slope (%)	N/A
N/A	Painted X Walk1?	No	N/A	Painted X Walk2?	N/A
	X Walk 1 Direction	To E		X Walk 2 Direction	N/A
N/A	X Walk 1 Width (in)	N/A	N/A	X Walk 2 Width (in)	N/A
	X Walk 1 Slope (%)	1.5		X Walk 2 Slope (%)	N/A
	X Walk 1 X Slope (%)	2.0		X Walk 2 X Slope (%)	N/A

N/A	Ramp inside XWalk1?	N/A	N/A	Ramp inside XWalk2?	N/A
	Road Slope (%)	N/A	N/A	Clear Space?	N/A
	Road X Slope (%)	N/A	N/A	Clear Space to XWalk (in)	N/A
N/A	Any Obstructions?	N/A	N/A	Storm Grate/Utility Hazard?	N/A
	Obstruction Type			Storm Grate/Utility Type	
		N/A			N/A
			Yes	Surface Condition? (G/P)	Good

Possible Solutions:

**Remove & Replace Entire Ramp.**
