# Access Compliance Report

## Public Rights-of-Way

### (Curb Ramps)

| Intersection ID: 26740 | Main Street: SIMFIELD_CHURCH_RD | Cross Street: WEDDINGTON_RD | Location: SE |

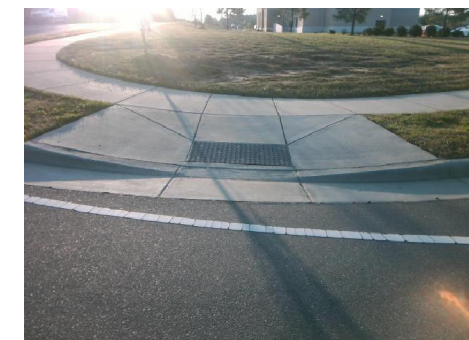
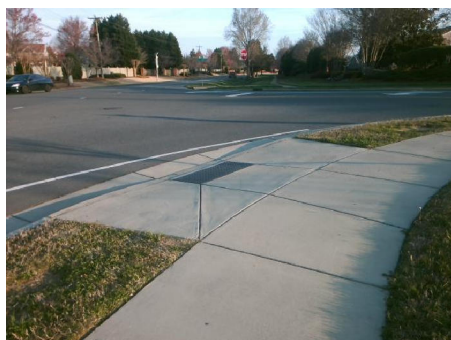
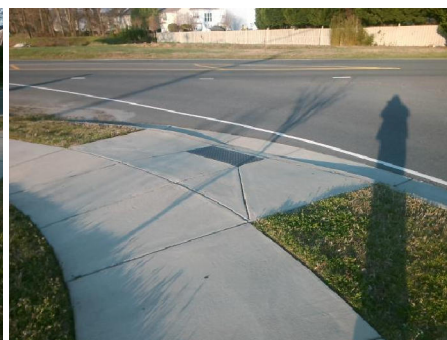
| ADA ID: B34C34AE2C93 | Ramp Type: Perp | Initial Pass/Fail: Fail | Overall Compliance: No |

**Not Found, R304.2.2, R304.5.3**

| Compliance | Description | Data | Compliance | Description | Data |
|---|---|---|---|---|---|
| N/A | Ramp Length (in) | 72.0 | No | Ramp Slope (%) | 11.5 |
| Yes | Ramp Width (in) | 48.0 | No | Ramp XSlope (%) | 4.5 |

**Remove & Replace Entire Ramp.**
