Access Compliance Report

Public Rights-of-Way

(Curb Ramps)

Intersection ID: 11343	Main Street: KEMPTON_PL	Cross Street: KERN_ST	Location: S
ADA ID: B352B1D28EE1	Ramp Type: Perp	Initial Pass/Fail: Fail	Overall Compliance: No
		Severity Score: 12.5

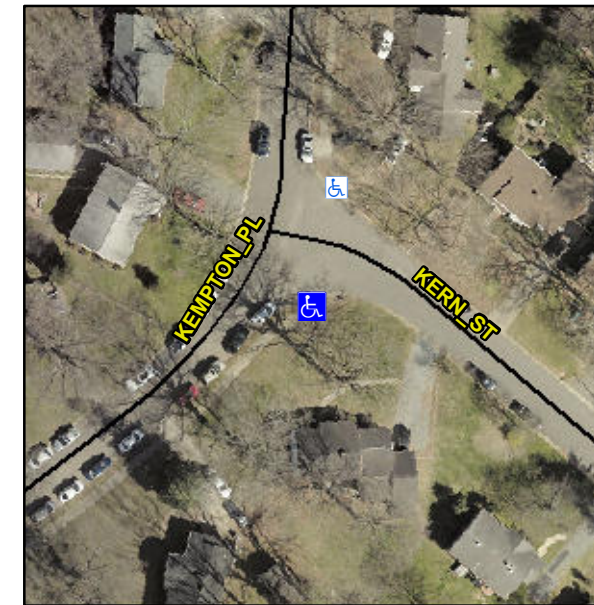
Not Found, R304.5.3

Compliance	Description	Data	Compliance	Description	Data
N/A	Ramp Length (in)	49.0	Yes	Ramp Slope (%)	6.7
Yes	Ramp Width (in)	48.0	No	Ramp XSlope (%)	5.1
N/A	Flare Type LT	N/A	N/A	Flare Type RT	N/A
N/A	Flare Slope LT (%)	N/A	N/A	Flare Slope RT (%)	N/A
N/A	Flare Traversable LT?	N/A	N/A	Flare Traversable RT?	N/A
N/A	Landing Length (in)	N/A	N/A	DWS Provided?	N/A
N/A	Landing Width (in)	N/A	N/A	DWS Contrast?	N/A
N/A	Landing Slope (%)	N/A	N/A	DWS Length (in)	N/A
N/A	Landing X Slope (%)	N/A	N/A	DWS Full Width?	N/A
N/A	Landing Curb? (Y/N)	N/A	N/A	DWS Offset (in)	N/A
N/A	Shared Landing?	N/A			
N/A	Gutter Ponding?	N/A	N/A	Gutter Slope (%)	N/A
N/A	Gutter Lip Ht (in)	N/A	N/A	Gutter X Slope (%)	N/A
N/A	Painted X Walk1?	No	N/A	Painted X Walk2?	N/A
	X Walk 1 Direction	To NE		X Walk 2 Direction	N/A
N/A	X Walk 1 Width (in)	N/A	N/A	X Walk 2 Width (in)	N/A
	X Walk 1 Slope (%)	8.6		X Walk 2 Slope (%)	N/A
	X Walk 1 X Slope (%)	1.9		X Walk 2 X Slope (%)	N/A

N/A	Ramp inside XWalk1?	N/A	N/A	Ramp inside XWalk2?	N/A
	Road Slope (%)	N/A	N/A	Clear Space?	N/A
	Road X Slope (%)	N/A	N/A	Clear Space to XWalk (in)	N/A
N/A	Any Obstructions?	N/A	N/A	Storm Grate/Utility Hazard?	N/A
	Obstruction Type			Storm Grate/Utility Type	
		N/A			N/A
		Yes		Surface Condition? (G/P)	Good

Remove & Replace Entire Ramp.
