Access Compliance Report

Public Rights-of-Way

(Curb Ramps)

Intersection ID: 10559	Main Street: CHARLES_AV	Cross Street: E_35TH_ST	Location: S
ADA ID: B35ECD7346D3	Ramp Type: Perp	Initial Pass/Fail: Fail	Overall Compliance: No
Severity Score: 8.75			
Codes/Mitigation Info/Possible Solution		Field Measurements/Component Compliance

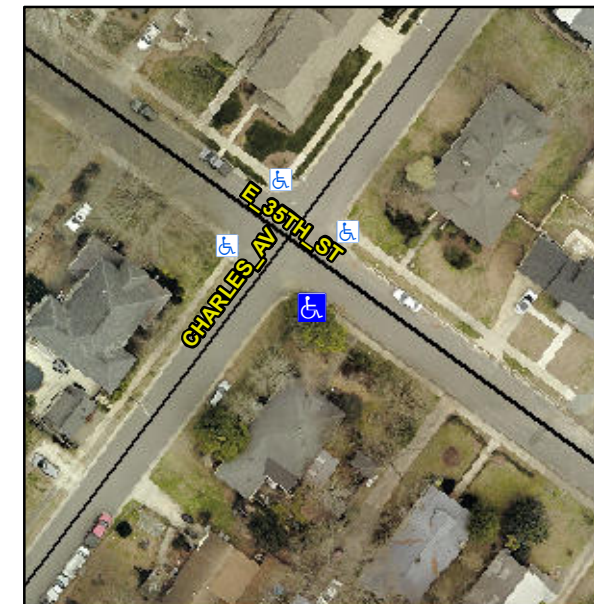
Not Found, R304.5.1

Compliance	Description	Data	Compliance	Description	Data
N/A	Ramp Length (in)	46.5	Yes	Ramp Slope (%)	7.7
No	Ramp Width (in)	47.0	Yes	Ramp XSlope (%)	1.0
N/A	Flare Type LT	N/A	N/A	Flare Type RT	N/A
N/A	Flare Slope LT (%)	N/A	N/A	Flare Slope RT (%)	N/A
N/A	Flare Traversable LT?	N/A	N/A	Flare Traversable RT?	N/A
N/A	Landing Length (in)	N/A	N/A	DWS Provided?	N/A
N/A	Landing Width (in)	N/A	N/A	DWS Contrast?	N/A
N/A	Landing Slope (%)	N/A	N/A	DWS Length (in)	N/A
N/A	Landing X Slope (%)	N/A	N/A	DWS Full Width?	N/A
N/A	Landing Curb? (Y/N)	N/A	N/A	DWS Offset (in)	N/A
N/A	Shared Landing?	N/A			
N/A	Gutter Ponding?	N/A	N/A	Gutter Slope (%)	N/A
N/A	Gutter Lip Ht (in)	N/A	N/A	Gutter X Slope (%)	N/A
N/A	Painted X Walk1?	No	N/A	Painted X Walk2?	N/A
	X Walk 1 Direction	To NW		X Walk 2 Direction	N/A
N/A	X Walk 1 Width (in)	N/A	N/A	X Walk 2 Width (in)	N/A
	X Walk 1 Slope (%)	0.5		X Walk 2 Slope (%)	N/A
	X Walk 1 X Slope (%)	0.6		X Walk 2 X Slope (%)	N/A

N/A	Ramp inside XWalk1?	N/A	N/A	Ramp inside XWalk2?	N/A
	Road Slope (%)	N/A	N/A	Clear Space?	N/A
	Road X Slope (%)	N/A	N/A	Clear Space to XWalk (in)	N/A
N/A	Any Obstructions?	N/A	N/A	Storm Grate/Utility Hazard?	N/A
	Obstruction Type			Storm Grate/Utility Type	
		N/A			N/A
			Yes	Surface Condition? (G/P)	Good

Remove & Replace Entire Ramp.
