# Access Compliance Report

## Public Rights-of-Way

| Intersection ID: 31970 | Main Street: BERNBROOKE CT | Cross Street: THORNTON OAKS CT | Location: SE |
| ADA ID: B3679D927EA3 | Ramp Type: BlendTrans1 | Initial Pass/Fail: Pass | Overall Compliance: No |

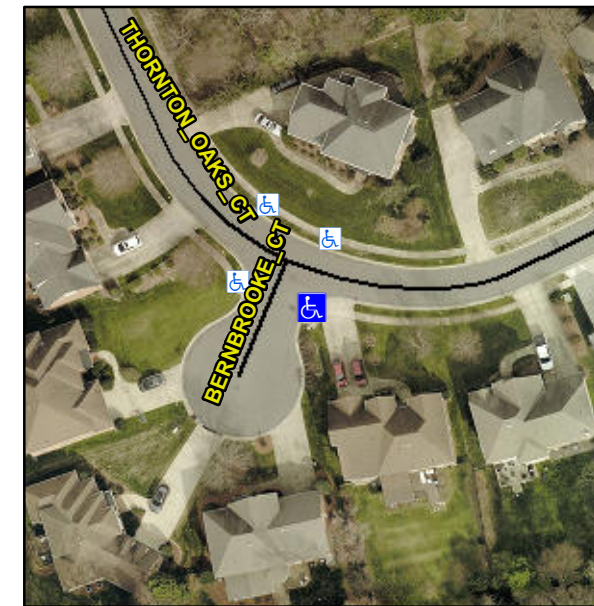
**N/A**

| Compliance | Description | Data | Compliance | Description | Data |
|---|---|---|---|---|---|
| No | Landing Length (in) | 46.5 | No | DWS Provided? | No |
| Yes | Gutter Ponding? | No | No | Gutter Slope (%) | 8.2 |

**Remove & Replace Curb Ramp With Two New Directional Ramps or Equivalent. Remove & Replace Gutter.**

**R304.2.1, R305, R304.5.4**

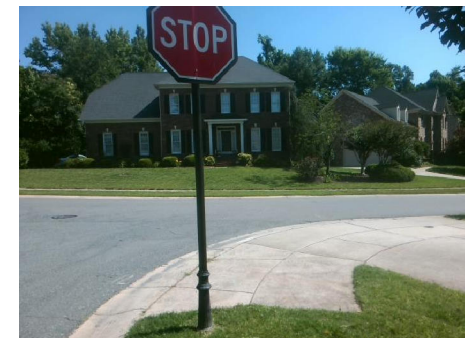
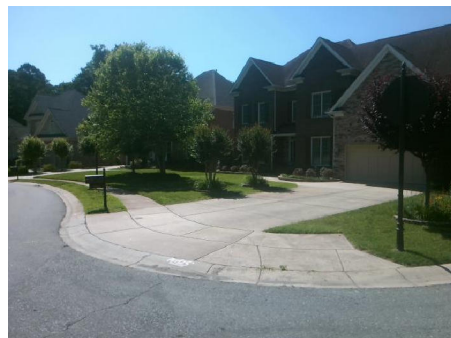
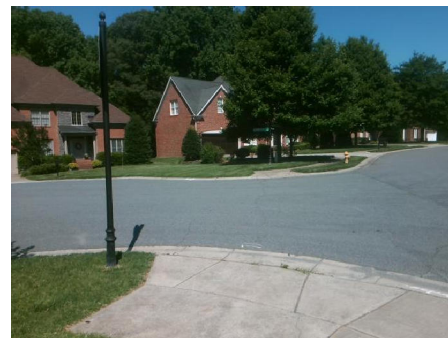
| | | Severity Score: 15 | |

Total Cost: \$ 3950.00
