# Access Compliance Report

## Public Rights-of-Way

### (Curb Ramps)

| Intersection ID: 10024872 | Main Street: DEWITT_LN | Cross Street: N/A | Location: SE |

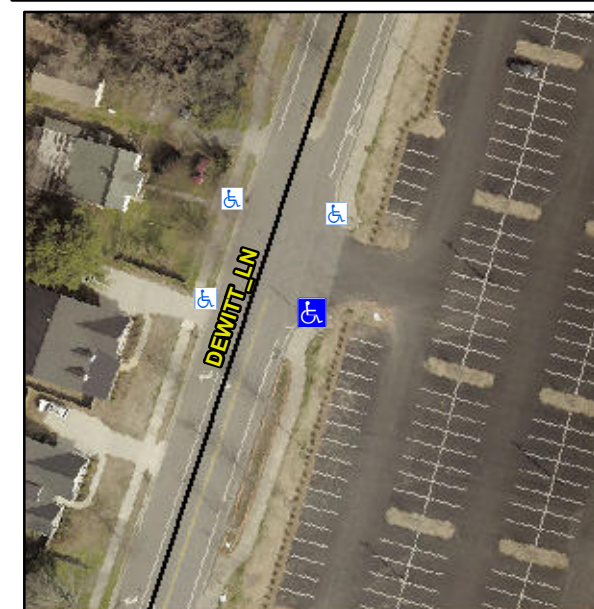
| ADA ID: B3682235270B | Ramp Type: PerpDiag | Initial Pass/Fail: Fail | Overall Compliance: No |
| Severity Score: 25 | | | |

**Not Found, R304.5.3**

| Compliance | Description | Data | Compliance | Description | Data |
|---|---|---|---|---|---|
| N/A | Ramp Length (in) | 94.0 | Yes | Ramp Slope (%) | 7.2 |
| Yes | Ramp Width (in) | 48.0 | No | Ramp XSlope (%) | 9.6 |

**Remove & Replace Curb Ramp With Two New Directional Ramps or Equivalent.**

Total Cost: \$ 3200.00
