Access Compliance Report Public Rights-of-Way (Curb Ramps)

Cross Street: WEXFORD_MEADOWS_LN Intersection ID: 28680 Main Street: OAK_LEIGH_DR Location: N ADA ID: B370E24F08E9 Ramp Type: Perp Initial Pass/Fail: Fail **Overall Compliance: No Severity Score:** 25

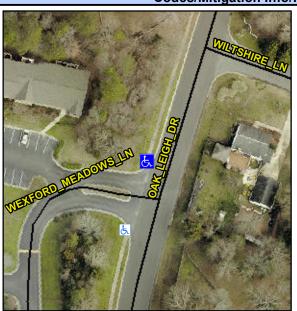
Comp	liance Description	Data	Comp	liance	Description	Data
N/A	Ramp Length (in)	53.0	No	Ramp	Slope (%)	15.5
Yes	Ramp Width (in)	48.0	Yes	Ramp	XSlope (%)	1.7
N/A	Flare Type LT	N/A	N/A	Flare	Type RT	N/A
N/A	Flare Slope LT (%)	N/A	N/A	Flare	Slope RT (%)	N/A
N/A	Flare Traversable LT?	N/A	N/A	Flare	Traversable RT?	N/A
N/A	Landing Length (in)	N/A	N/A	DWS	Provided?	N/A
N/A	Landing Width (in)	N/A	N/A	DWS	Contrast?	N/A
N/A	Landing Slope (%)	N/A	N/A	DWS	Length (in)	N/A
N/A	Landing X Slope (%)	N/A	N/A	DWS	Full Width?	N/A
N/A	Landing Curb? (Y/N)	N/A	N/A	DWS	Offset (in)	N/A
N/A	Shared Landing?	N/A				
N/A	Gutter Ponding?	N/A	N/A	Gutte	r Slope (%)	N/A
N/A	Gutter Lip Ht (in)	N/A	N/A	Gutte	r X Slope (%)	N/A
N/A	Painted X Walk1?	No	N/A	Paint	ed X Walk2?	N/A
	X Walk 1 Direction	To SW		X Wa	lk 2 Direction	N/A
N/A	X Walk 1 Width (in)	N/A	N/A	X Wa	lk 2 Width (in)	N/A
	X Walk 1 Slope (%)	0.8		X Wa	lk 2 Slope (%)	N/A
	X Walk 1 X Slope (%)	5.0		X Wa	lk 2 X Slope (%)	N/A

N/A	Ramp inside XWalk1?	N/A	N/A	Ramp	inside XWalk2?	N/A
	Road Slope (%)	N/A	N/A	Clear	Space?	N/A
	Road X Slope (%)	N/A	N/A	Clear	Space to XWalk (in)	N/A
N/A	Any Obstructions?	N/A	N/A	Storm	n Grate/Utility Hazard?	N/A
	Obstruction Type			Storm	n Grate/Utility Type	
		N/A				N/A
			Yes	Surfa	ce Condition? (G/P)	Good

1 OSSIDIE OCIULION							
Possible Solutions:							
Remove & Replace Entire Ramp.							
Ourse Notes							
Surveyor Notes:							
N/A							
PROW/ADA:							
R304.2.2

PROW/ADA:		N/A
R304.2.2		N/A
		N/A
		N/A
		N/A
Total Cost	\$ 1850.00	N/A
Total Cost:	\$ 1850.00
