## **Access Compliance Report Public Rights-of-Way** (Curb Ramps)

Intersection ID: 20184 Main Street: SOUTH PARK DR **Cross Street: SHARON RD** Location: Ε

**Overall Compliance: No Severity Score: ADA ID: B37DA3B665BF** Ramp Type: PerpDiag Initial Pass/Fail: Fail 8.75

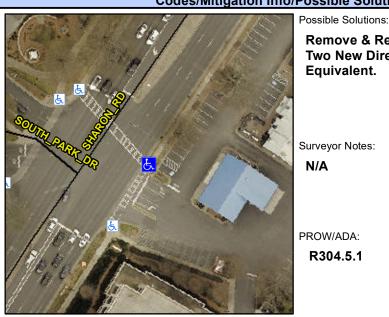
Yes No Ramp Width (in) 38.5 N/A N/A Flare Type LT N/A N/A N/A N/A Flare Slope LT (%) N/A Flare Traversable LT? N/A N/A N/A N/A N/A Landing Length (in) N/A Landing Width (in) N/A N/A N/A N/A N/A Landing Slope (%) N/A Landing X Slope (%) N/A N/A N/A Landing Curb? (Y/N) N/A N/A N/A N/A Shared Landing? N/A **Gutter Ponding?** N/A N/A N/A Gutter Lip Ht (in) 1.0 N/A N/A Painted X Walk1? Yes N/A X Walk 1 Direction To NW N/A 80.0 N/A X Walk 1 Width (in) X Walk 1 Slope (%) 2.2 X Walk 1 X Slope (%) 0.6 N/A N/A Ramp inside XWalk1? Yes Road Slope (%) 0.6 N/A N/A Road X Slope (%) 4.7 N/A N/A N/A Any Obstructions?

Street 1 Name Stop Condition-Street 2 Street 2 Name Stop Condition-Street 1 Remove & Replace Curb Ramp With Two New Directional Ramps or Equivalent.

R304.5.1
