Access Compliance Report

Public Rights-of-Way

(Curb Ramps)

Intersection ID: N/A	Main Street: E_4TH_ST	Cross Street: S_CALDWELL_ST	Location: E
ADA ID: B38CA8A6335D	Ramp Type: Perp	Initial Pass/Fail: Fail	Overall Compliance: No
		Severity Score: 22.5	
Codes/Mitigation Info/Possible Solution		Field Measurements/Component Compliance

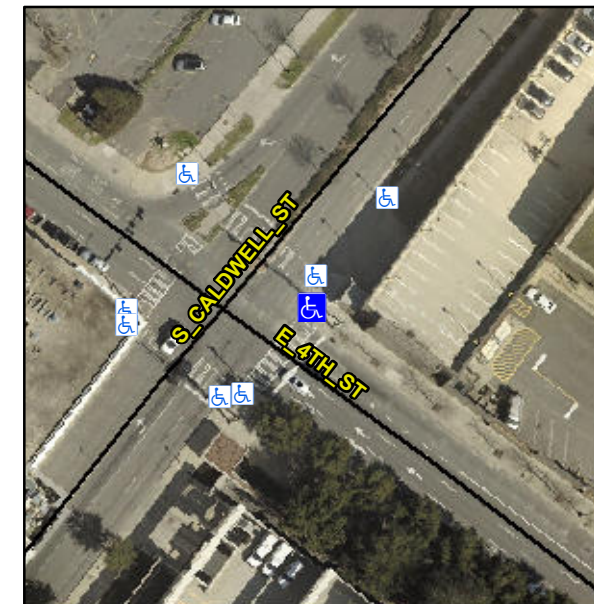
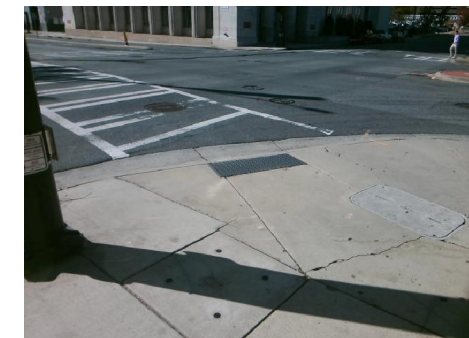
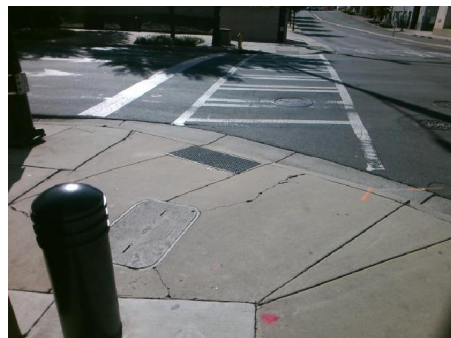
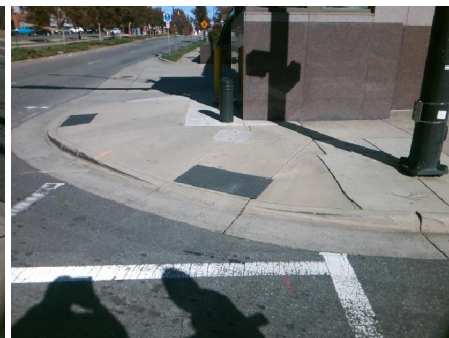
Not Found, R304.5.1, R304.2.2

Compliance	Description	Data	Compliance	Description	Data
N/A	Ramp Length (in)	60.0	No	Ramp Slope (%)	9.3
No	Ramp Width (in)	46.0	Yes	Ramp XSlope (%)	3.8
N/A	Flare Type LT	N/A	N/A	Flare Type RT	N/A
N/A	Flare Slope LT (%)	N/A	N/A	Flare Slope RT (%)	N/A
N/A	Flare Traversable LT?	No	N/A	Flare Traversable RT?	No
N/A	Landing Length (in)	N/A	N/A	DWS Provided?	N/A
N/A	Landing Width (in)	N/A	N/A	DWS Contrast?	N/A
N/A	Landing Slope (%)	N/A	N/A	DWS Length (in)	N/A
N/A	Landing X Slope (%)	N/A	N/A	DWS Full Width?	N/A
N/A	Landing Curb? (Y/N)	N/A	N/A	DWS Offset (in)	N/A
N/A	Shared Landing?	N/A			
N/A	Gutter Ponding?	N/A	N/A	Gutter Slope (%)	N/A
N/A	Gutter Lip Ht (in)	N/A	N/A	Gutter X Slope (%)	N/A
N/A	Painted X Walk1?	Yes	N/A	Painted X Walk2?	N/A
	X Walk 1 Direction	To SW		X Walk 2 Direction	N/A
N/A	X Walk 1 Width (in)	120.0	N/A	X Walk 2 Width (in)	N/A
	X Walk 1 Slope (%)	6.5		X Walk 2 Slope (%)	N/A
	X Walk 1 X Slope (%)	4.8		X Walk 2 X Slope (%)	N/A

N/A	Ramp inside XWalk1?	Yes	N/A	Ramp inside XWalk2?	N/A
	Road Slope (%)	N/A	N/A	Clear Space?	N/A
	Road X Slope (%)	N/A	N/A	Clear Space to XWalk (in)	N/A
N/A	Any Obstructions?	N/A	N/A	Storm Grate/Utility Hazard?	N/A
	Obstruction Type			Storm Grate/Utility Type	
		N/A			N/A
			Yes	Surface Condition? (G/P)	Good

Remove & Replace Entire Ramp.
