Access Compliance Report Public Rights-of-Way (Curb Ramps)

Intersection ID: 7022Main Street:CROSSPOINT_CENTER_LNCross Street: HUTCHISON-MCDONALD_RDLocation:NEADA ID: B38CF85ABC28Ramp Type:PerpInitial Pass/Fail: FailOverall Compliance: NoSeverity Score:12.5

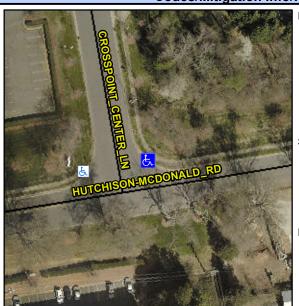
Field Measurements/Component Compliance						
Comp	liance Description	Data	Comp	liance Description	Data	
N/A	Ramp Length (in)	67.0	No	Ramp Slope (%)	9.0	
Yes	Ramp Width (in)	48.0	Yes	Ramp XSlope (%)	0.7	
N/A	Flare Type LT	N/A	N/A	Flare Type RT	N/A	
N/A	Flare Slope LT (%)	N/A	N/A	Flare Slope RT (%)	N/A	
N/A	Flare Traversable LT?	N/A	N/A	Flare Traversable RT?	N/A	
N/A	Landing Length (in)	N/A	N/A	DWS Provided?	N/A	
N/A	Landing Width (in)	N/A	N/A	DWS Contrast?	N/A	
N/A	Landing Slope (%)	N/A	N/A	DWS Length (in)	N/A	
N/A	Landing X Slope (%)	N/A	N/A	DWS Full Width?	N/A	
N/A	Landing Curb? (Y/N)	N/A	N/A	DWS Offset (in)	N/A	
N/A	Shared Landing?	N/A				
N/A	Gutter Ponding?	N/A	N/A	Gutter Slope (%)	N/A	
N/A	Gutter Lip Ht (in)	0.5	N/A	Gutter X Slope (%)	N/A	
N/A	Painted X Walk1?	No	N/A	Painted X Walk2?	N/A	
	X Walk 1 Direction	To W		X Walk 2 Direction	N/A	
N/A	X Walk 1 Width (in)	N/A	N/A	X Walk 2 Width (in)	N/A	
	X Walk 1 Slope (%)	2.8		X Walk 2 Slope (%)	N/A

· CCCIDIC CCIGNON			
Possible Solutions:	<u>c</u>		
Remove & Replace Entire Ramp.			
·	Υ		
	N		
	N		
	N		
	N		
Surveyor Notes:	N		
N/A	N		
	N		
	N		
	N		
PROW/ADA:	N		
Not Found, R304.2.2	N		
·	N		
	N

Total Cost: \$ 1850.00
