# Access Compliance Report

## Public Rights-of-Way

Intersection ID: 23987	Main Street: PRESCOTT_POND_LN	Cross Street: TREYFORD_LN	Location: SE
ADA ID: B396BBF1F288	Ramp Type: PerpDiag	Initial Pass/Fail: Fail	Overall Compliance: No
Severity Score: 35			
Codes/Mitigation Info/Possible Solution		Field Measurements/Component Compliance

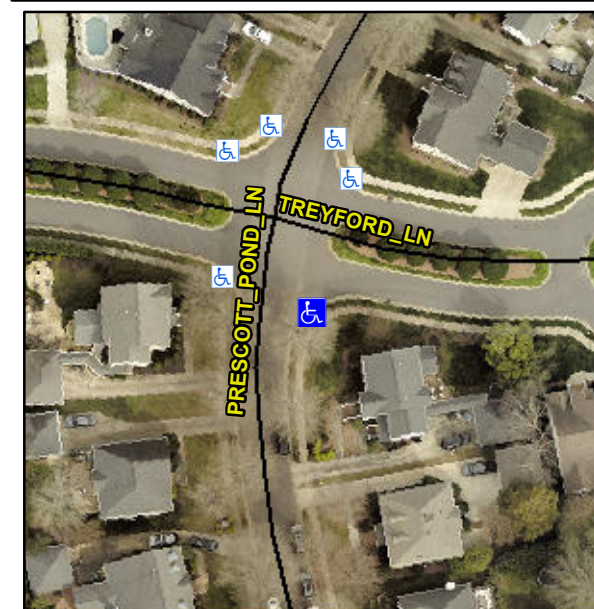
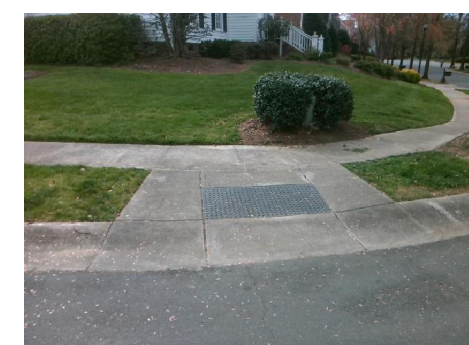
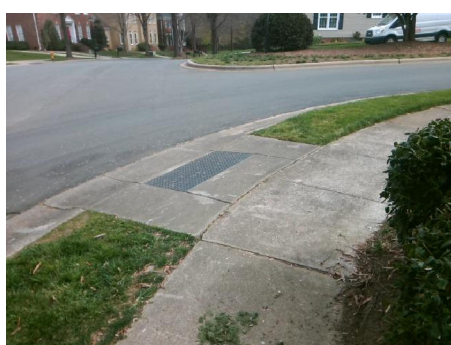
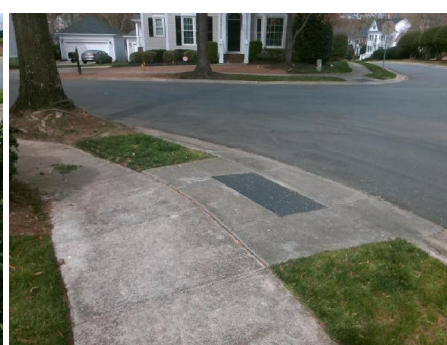
**Not Found, R304.5.1, R304.2.2, R304.5.3**

Compliance	Description	Data	Compliance	Description	Data
N/A	Ramp Length (in)	46.0	No	Ramp Slope (%)	12.1
No	Ramp Width (in)	47.0	No	Ramp XSlope (%)	2.4
N/A	Flare Type LT	N/A	N/A	Flare Type RT	N/A
N/A	Flare Slope LT (%)	N/A	N/A	Flare Slope RT (%)	N/A
N/A	Flare Traversable LT?	N/A	N/A	Flare Traversable RT?	N/A
N/A	Landing Length (in)	N/A	N/A	DWS Provided?	N/A
N/A	Landing Width (in)	N/A	N/A	DWS Contrast?	N/A
N/A	Landing Slope (%)	N/A	N/A	DWS Length (in)	N/A
N/A	Landing X Slope (%)	N/A	N/A	DWS Full Width?	N/A
N/A	Landing Curb? (Y/N)	N/A	N/A	DWS Offset (in)	N/A
N/A	Shared Landing?	N/A			
N/A	Gutter Ponding?	N/A	N/A	Gutter Slope (%)	N/A
N/A	Gutter Lip Ht (in)	N/A	N/A	Gutter X Slope (%)	N/A
N/A	Painted X Walk1?	No	N/A	Painted X Walk2?	No
	X Walk 1 Direction	To N		X Walk 2 Direction	To W
N/A	X Walk 1 Width (in)	N/A	N/A	X Walk 2 Width (in)	N/A
	X Walk 1 Slope (%)	1.3		X Walk 2 Slope (%)	2.0
	X Walk 1 X Slope (%)	1.4		X Walk 2 X Slope (%)	0.8

N/A	Ramp inside XWalk1?	N/A	N/A	Ramp inside XWalk2?	N/A
	Road Slope (%)	2.0	N/A	Clear Space?	N/A
	Road X Slope (%)	0.6	N/A	Clear Space to XWalk (in)	N/A
N/A	Any Obstructions?	N/A	N/A	Storm Grate/Utility Hazard?	N/A
	Obstruction Type			Storm Grate/Utility Type	
		N/A			N/A
			Yes	Surface Condition? (G/P)	Good

**Remove & Replace Curb Ramp With Two New Directional Ramps or Equivalent.**

Total Cost: \$ 3200.00
