# Access Compliance Report

## Public Rights-of-Way (Curb Ramps)

Intersection ID: 14318	Main Street: LAWRENCE_ORR_RD	Cross Street: WALLACE_AV	Location:	S
ADA ID: B396F16BBCB1	Ramp Type: Perp	Initial Pass/Fail: Fail	Overall Compliance: No	Severity Score: 10
Codes/Mitigation Info/Possible Solution		Field Measurements/Component Compliance

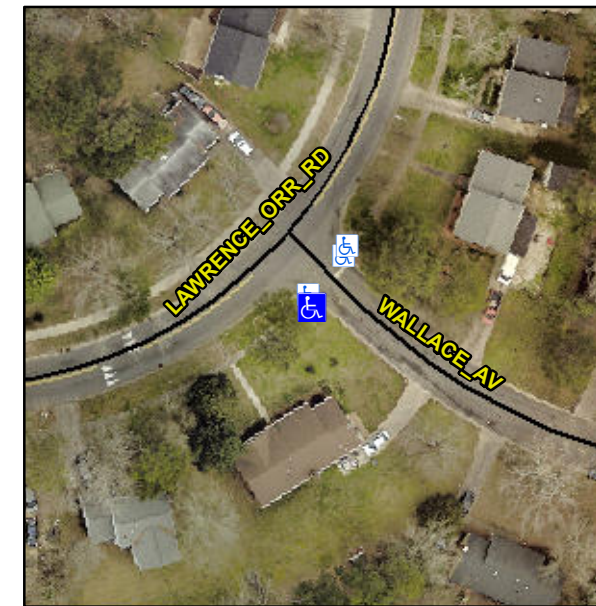
**Not Found, R304.5.1, R304.5.3**

Compliance	Description	Data	Compliance	Description	Data
N/A	Ramp Length (in)	95.0	Yes	Ramp Slope (%)	5.7
No	Ramp Width (in)	43.0	No	Ramp XSlope (%)	2.3
N/A	Flare Type LT	N/A	N/A	Flare Type RT	N/A
N/A	Flare Slope LT (%)	N/A	N/A	Flare Slope RT (%)	N/A
N/A	Flare Traversable LT?	N/A	N/A	Flare Traversable RT?	N/A
N/A	Landing Length (in)	N/A	N/A	DWS Provided?	N/A
N/A	Landing Width (in)	N/A	N/A	DWS Contrast?	N/A
N/A	Landing Slope (%)	N/A	N/A	DWS Length (in)	N/A
N/A	Landing X Slope (%)	N/A	N/A	DWS Full Width?	N/A
N/A	Landing Curb? (Y/N)	N/A	N/A	DWS Offset (in)	N/A
N/A	Shared Landing?	N/A			
N/A	Gutter Ponding?	N/A	N/A	Gutter Slope (%)	N/A
N/A	Gutter Lip Ht (in)	N/A	N/A	Gutter X Slope (%)	N/A
N/A	Painted X Walk1?	No	N/A	Painted X Walk2?	N/A
	X Walk 1 Direction	To NE		X Walk 2 Direction	N/A
N/A	X Walk 1 Width (in)	N/A	N/A	X Walk 2 Width (in)	N/A
	X Walk 1 Slope (%)	5.8		X Walk 2 Slope (%)	N/A
	X Walk 1 X Slope (%)	5.0		X Walk 2 X Slope (%)	N/A

N/A	Ramp inside XWalk1?	N/A	N/A	Ramp inside XWalk2?	N/A
	Road Slope (%)	N/A	N/A	Clear Space?	N/A
	Road X Slope (%)	N/A	N/A	Clear Space to XWalk (in)	N/A
N/A	Any Obstructions?	N/A	N/A	Storm Grate/Utility Hazard?	N/A
	Obstruction Type			Storm Grate/Utility Type	
		N/A			N/A
			Yes	Surface Condition? (G/P)	Good

**Remove & Replace Entire Ramp.**

Total Cost: \$ 1850.00
